## REPORT

Targeted Road Safety Inspection on Road II-13 in a Section with Concentration of RTAs from km 65+440 to km 66+200

12 August 2025 / from 17:30 to 18:30 GMT +3

**Final Report**

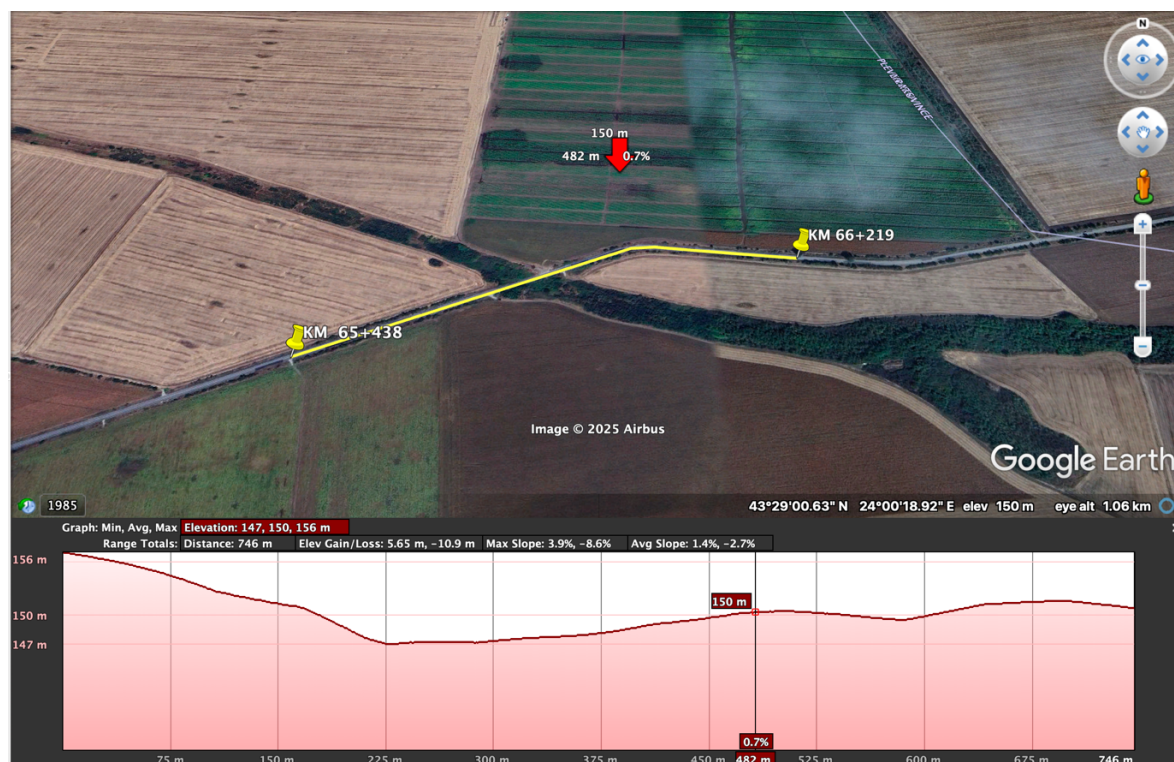
Figure 1 – Visibility study in the inspected road section II-1.

The visibility distance in the section km 65+440 to km 66+200 is marginally permissible for a speed regime up to 50 km/h, as currently in force. At this speed, the minimum regulatory value for stopping sight distance is approximately 65–70 m, which is approximately provided at the lowest point of the vertical curve. Nevertheless, the combination of horizontal right and vertical sag curves continues to limit visual contact between oncoming vehicles and reduces the possibility of timely reaction in the event of a hazard occurring.

Therefore, although formally the speed limit of 50 km/h compensates for some of the geometric deficiencies, the section remains risky, especially on wet pavement, nighttime or by drivers who do not comply with the limits. It is recommended that the current speed limit be maintained, supplemented by warning signage for limited visibility, and periodic mowing of vegetation in the inner shoulder area to ensure real visibility distance corresponding to safe braking.

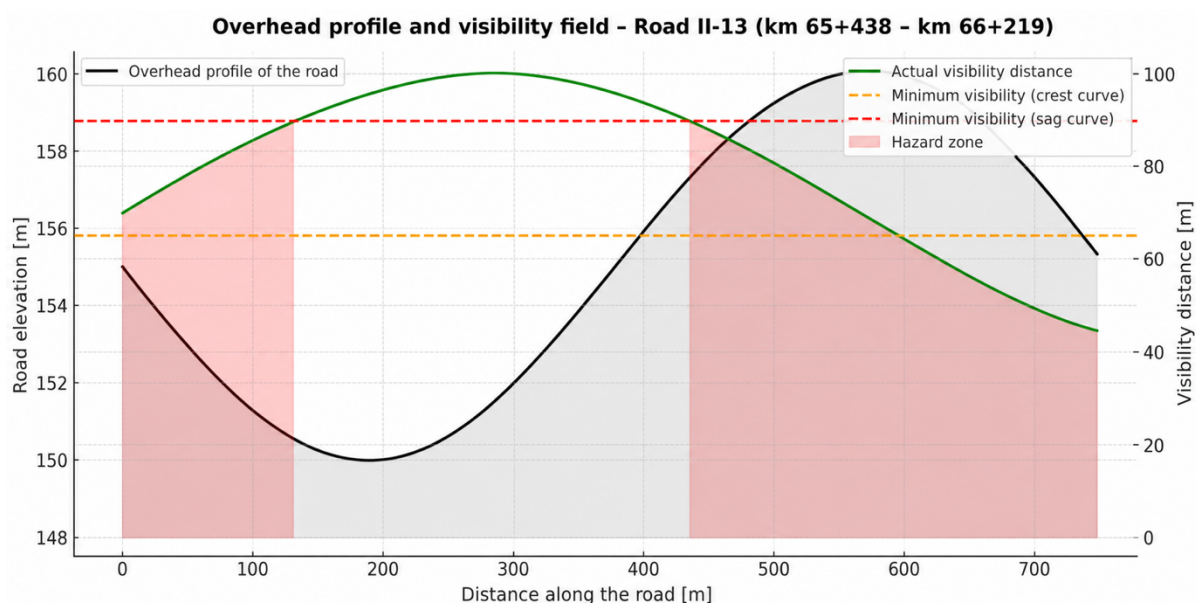
Figure 2 – Overhead profile and visibility field – Road II-13 from km 65+438 to km 66+200.

The minimum required stopping sight distance at a speed of 50 km/h, calculated under standard conditions (reaction time 2 seconds, eye height 1.1 m, road gradient up to 8.6%), is in the range between 60 and 70 meters on dry pavement with good adhesion. On wet pavement with reduced adhesion, the required distance may reach 90–100 meters. This means that the visibility in the considered section is at the limit of what is normatively permissible, and under adverse weather conditions it may prove insufficient. Therefore, the speed limit of 50 km/h should be maintained, with regular mowing and maintenance of the inner shoulder, removal of obstructing vegetation and placement of warning signs for limited visibility. These measures would ensure real safety and correspondence between the road geometric characteristics, the speed regime and the required distance for safe braking.

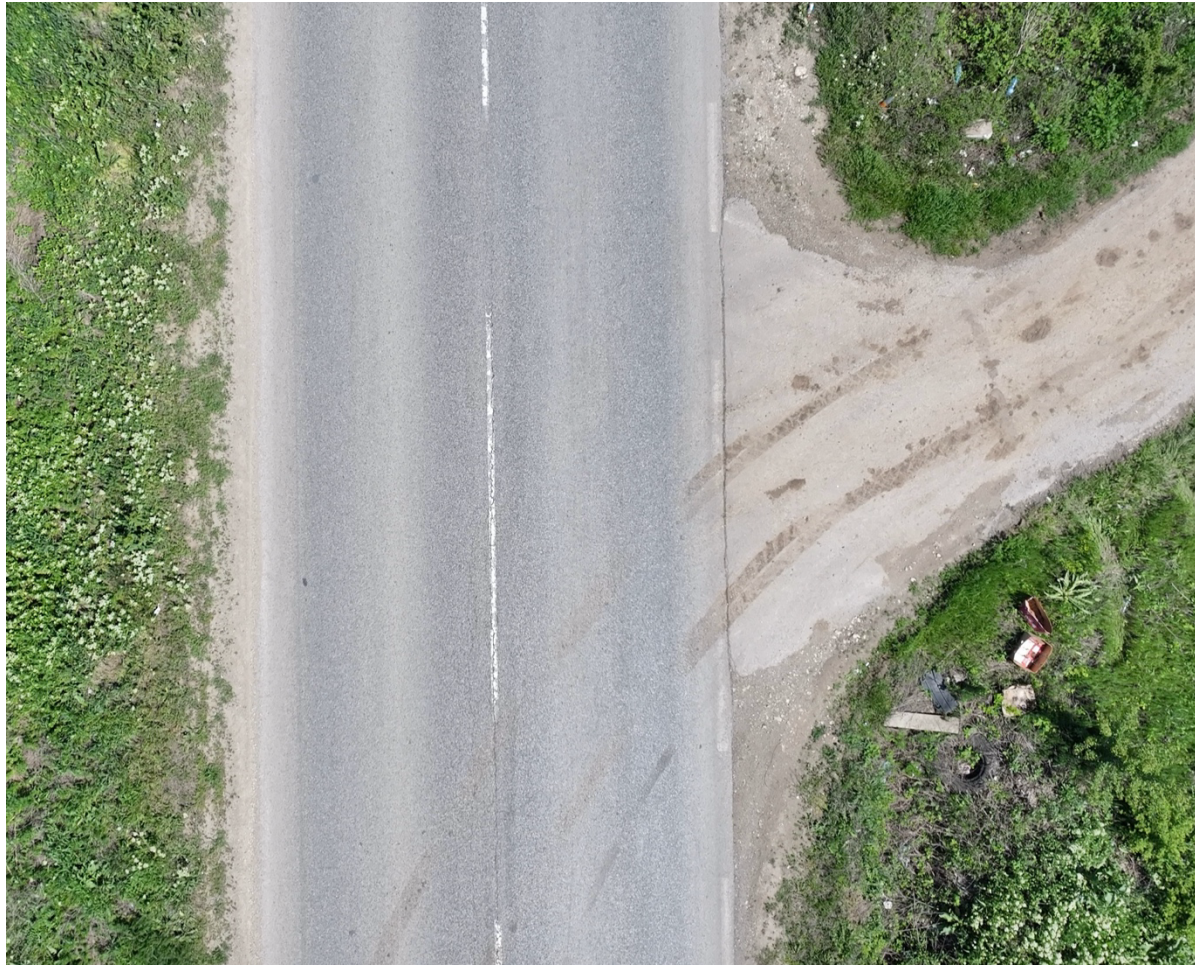
*Figure 12 – Condition of the unregulated intersection between road II-13 and an agricultural-dirt road at km 65+717. Excerpt from surveying performed by the ECTP using the remote sensing method.*

Another substantial omission is the absence of warning road signs A27 and A28, indicating respectively “intersection with a road without priority”. In this manner, drivers traveling on the main direction are not warned of the possible entry from a dirt road, while drivers exiting from it have no visual information about the nature of the connection and their obligation to yield to traffic. This is a direct violation of Ordinance No. RD-02-21-1 of 23 November 2023 on road signing with road signs. The principle established in this subordinate regulatory act is that before every location of merging or crossing of roads, the respective warning signs shall be installed, especially when visibility is limited or traffic is intensive.

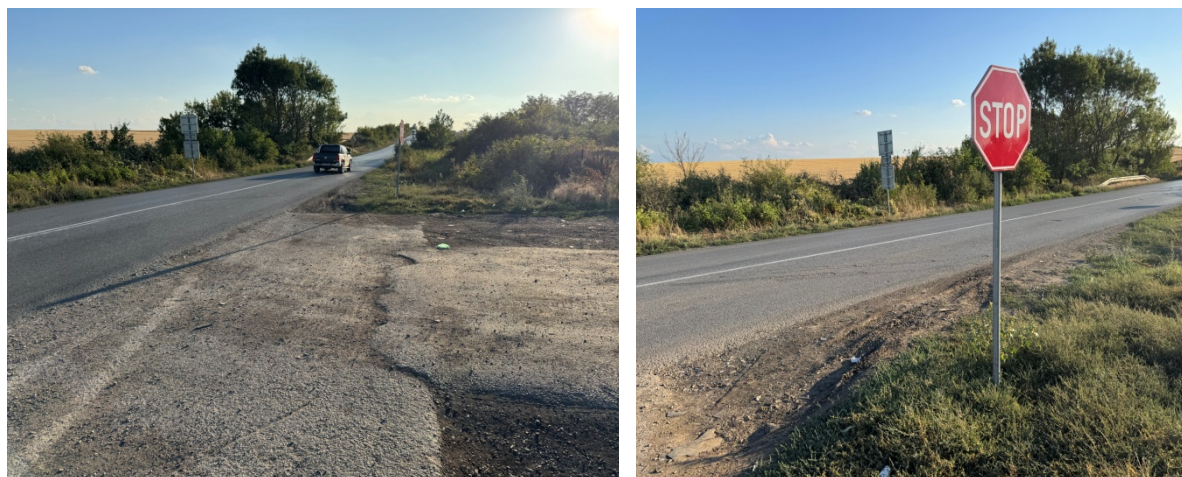
Figure 18 – The presence of asphalt pavement at the turn-off for the agricultural/forest road and the presence of road sign B2 on the left side in the direction from town Byala Slatina to town Knezha were established. Sign A26 is missing.

This intersection is also not marked with warning road sign A26. If we assume that the connection from the south side is unregulated, then there should have been signs A27 and A28. The absence of warning road signs is a substantial deficiency directly affecting safety. Nothing warns road users that within the road scope they should expect the appearance of agricultural, forest machinery or other vehicles exiting this intersection. In this manner, drivers do not have the necessary and correct information to adapt their behavior to the actual road conditions.

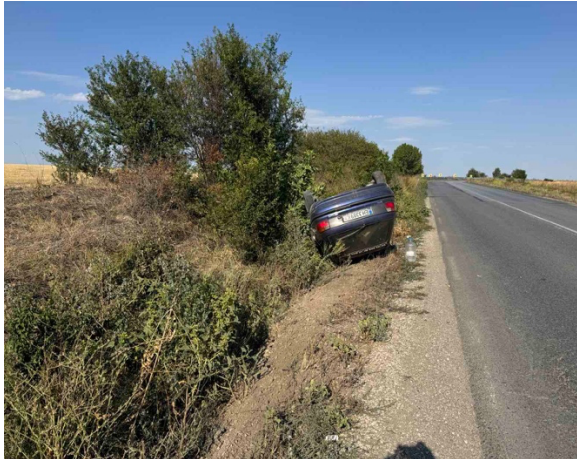
On 09 September 2025, a road traffic accident occurred when a bus turning left towards the intersection at km 65+806 (old project) from the main direction was hit by a car, because the car was overtaking within the scope of the intersection. In principle, the car driver had no way of knowing that there was an intersection there and consequently to take this into account and not undertake the overtaking maneuver. As a result of the occurred accident, the passenger car rolled over onto its roof, and the driver and passenger were injured.

Figure 19 – Photo of the car that collided with the bus.

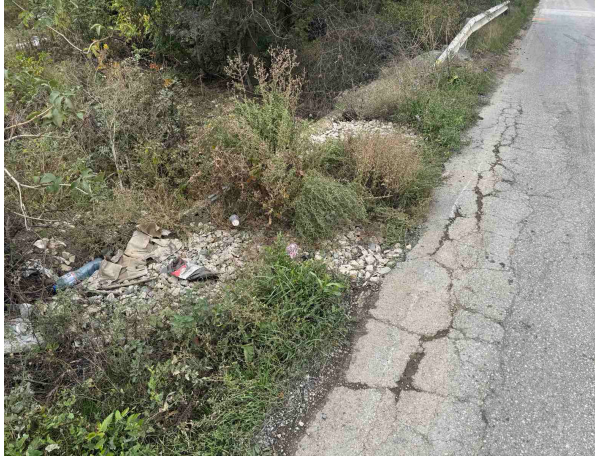
In the road section passing over the culvert, numerous longitudinal and mesh-like cracks are observed, running along the edge of the carriageway. This is a sign of loss of bearing capacity of the subgrade and infiltration of surface waters. There are deformations and local settlements along the edge of the pavement, which compromises the stability of the structure.

The restraint system is in an unstable condition, with its posts partially exposed and without firm soil support. At the base, erosional cavities and undermining are observed, as a result of which the effective working length of the system is reduced and it would not be able to retain a vehicle upon impact.

*Figure 22 – Condition of the surface above the culvert.*

Immediate cleaning of vegetation and debris in the culvert zone, restoration of its conveyance capacity and structural inspection by a structural engineer are necessary in order to determine the degree of undermining and the required strengthening measures. Injection and concreting of the cavities, restoration of the pavement with laying of a new wearing course and waterproofing, as well as replacement or strengthening of the restraint system are recommended. It is necessary to construct erosion protection at the inlet and outlet of the culvert and to place temporary warning signs until the risk is eliminated.

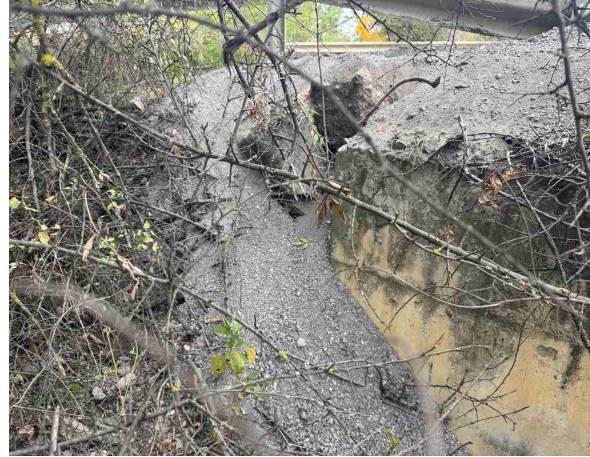
*Figure 23 – Condition of the culvert at the road maintenance base, view from the north side.*

The concrete headwalls of the culvert exhibit deep cavities, cracks and voids beneath the foundation, evidencing an active erosion process. In the lower part, openings are observed through which water has begun to undermine the headwalls and the foundation of the structure. From the upper side, detachment and destruction of the

asphalt layer is visible, indicating absence or deterioration of the waterproofing layer between the pavement and the structure.

The inlet and outlet of the culvert are densely overgrown with vegetation and filled with sediment and debris, which severely limits the conveyance capacity of the structure. During heavy rainfall, this creates a precondition for surface overflow and undermining of the headwalls. Stone or concrete lining reinforcement is missing, which further accelerates the erosion processes.

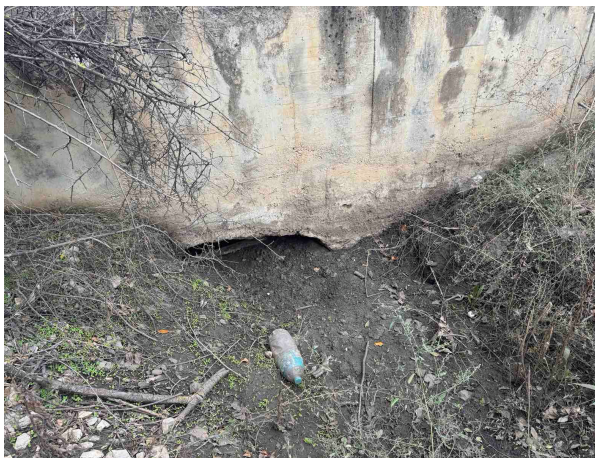
*Figure 24 – Condition of the culvert – view from the south side of the road (direction of travel from town Byala Slatina to town Knezha).*

The condition of the structure gives rise to high structural and hydraulic risk, as there is a real probability of local collapse of the headwalls and failure of the road pavement. During heavy rainfall, blockage of the water opening and overflow are possible, which will lead to compromise of the road body. The operational risk is medium to high, especially during passage of heavy goods vehicles.

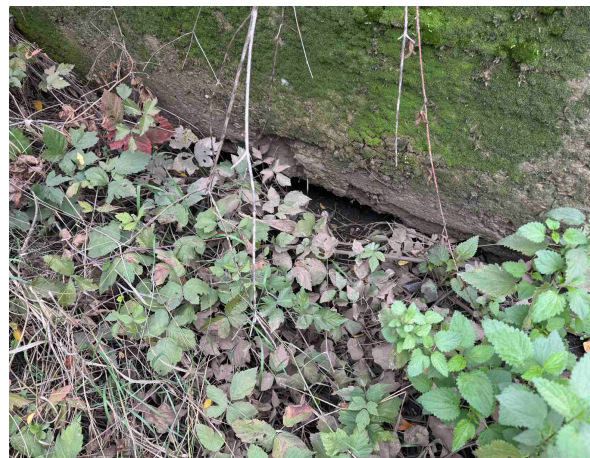
*Figure 25 – Condition of the culvert – view from the north side of the road (direction of travel from town Knezha to town Byala Slatina).*

The culvert structure is in a pre-emergency condition. The erosion processes, cracks in the pavement, undermining of the headwalls and blockage of the water opening represent a serious risk to the operational suitability of the road and traffic safety. Urgent engineering-restoration actions must be undertaken in order to prevent local collapse and ensure long-term stability of the structure.

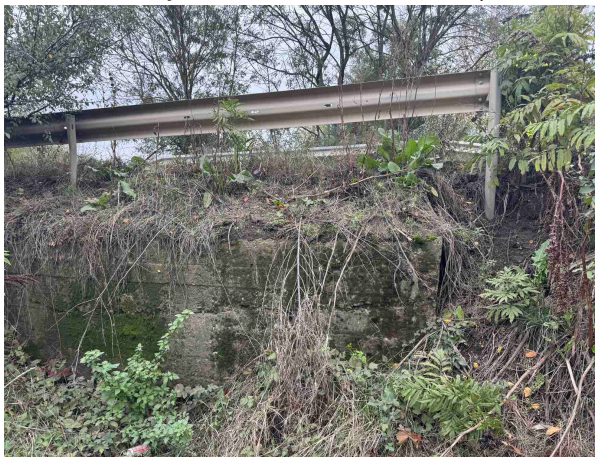
*Figure 26 – Condition of the road maintenance base above the culvert (the northern from the south side).*

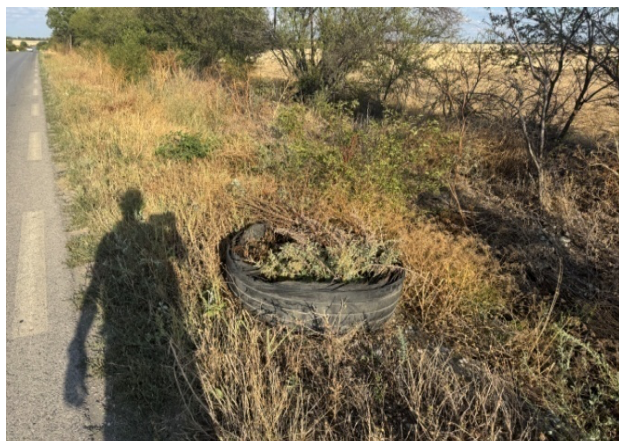
The road shoulders in the studied section are grassy, formed relatively uniformly in width, but do not differ distinctly from the edge of the road pavement. In some zones, the shoulders are visibly higher than the level of the traffic lane. This creates unfavorable conditions for rapid runoff of surface waters during rainfall – water is retained on the shoulder and part of it is directed back towards the asphalt pavement.

Shoulders must perform three main functions: zone for emergency stopping in extraordinary situations, drainage and reinforcement of the pavement edge. In the considered section, these functions are partially compromised. The high and grass-covered shoulders do not allow safe short-term stopping of a vehicle, as they are soft and unsecured, while the presence of dense vegetation hampers maneuvering. Furthermore, the locations where the shoulder is higher than the pavement additionally impede water drainage and increase the risk of aquaplaning.

Figure 27 – Condition of the shoulder – right traffic lane in the direction of travel (town Byala Slatina → town Knezha).

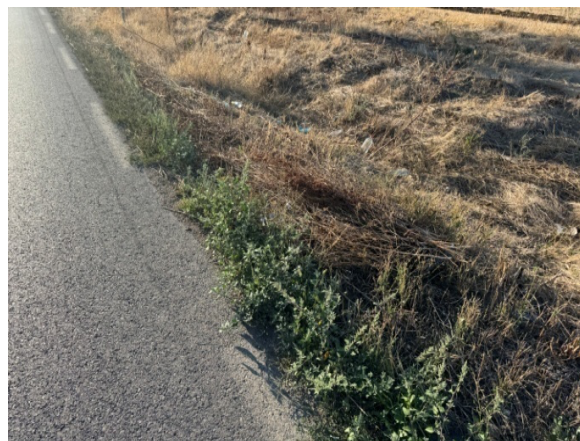
During the performed inspection, it was established that periodic attempts have been made in recent years to clear vegetation on the shoulder, but due to the systematic lack of maintenance, the grass and shrub layer is again dense and thick. In places, individual shrubs encroach into the road clearance gauge and limit visibility, especially in the curve. Where shoulders are at an elevated level above the road pavement and vegetation is not regularly cut, conditions are created for water accumulation and local erosion processes.

Figure 28 – Condition of the shoulder – left traffic lane in the direction of travel (town Knezha ← town Byala Slatina).

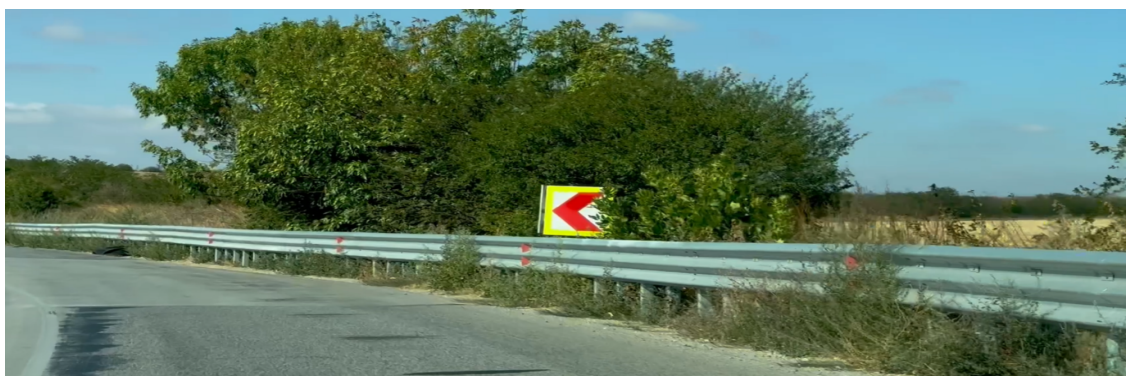
In the curve, in some places the restraint system located in the left lane in the direction of town Byala Slatina is positioned too close to the edge and practically leaves no working zone for trajectory recovery (“shy distance”). The glossy traces in the zone of tangential wear in some of the curves are a sign of smoothing/bleeding and reduced microtexture – precisely where the transverse forces are greatest. The combination of narrow shoulder, poorly positioned restraint system and weakened texture creates an unfavorable scenario: upon a minor error, the driver first “catches” the edge, loses stability and ends up in the barrier.

*Figure 31 – Road restraint system in the curve in the direction from town Knezha to town Byala Slatina, where it is clearly visible that vegetation has not been cleared beyond the edge of the pavement.*

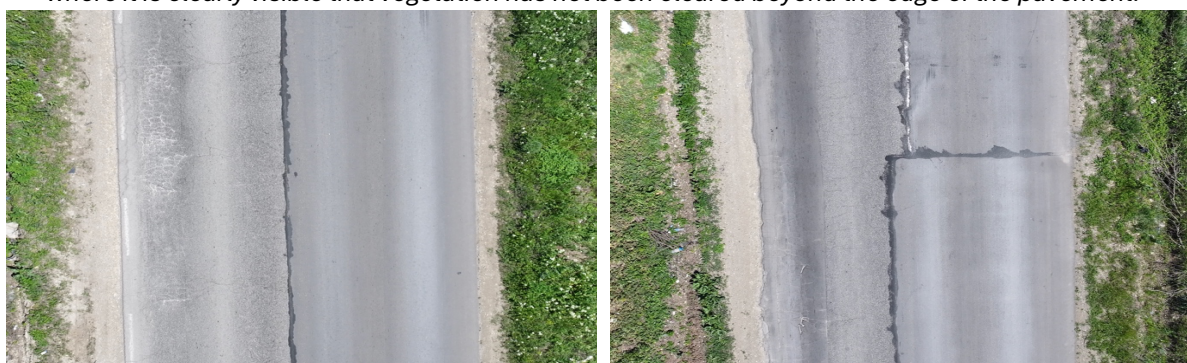
The edge of the pavement in the considered section is not in good operational condition. In places, longitudinal cracks and local spalling were identified. The shoulder is narrow, unreinforced and with active overgrowth; penetration of fine particles and water at the pavement–shoulder contact is visible, which accelerates undermining of the edge and development of cracks. In some of the zones alongside the lane, the edge is visually “lost”, and a distinct edge line is also missing (missing marking), which at dusk, in rain or when dazzled by oncoming lights increases the probability that the driver will lose orientation and leave the traffic lane in which they are traveling.

*Figure 32 – Condition of the edge of the pavement, footage captured by the remote sensing method.  
The survey was performed by the EUCTP team in April 2025.*

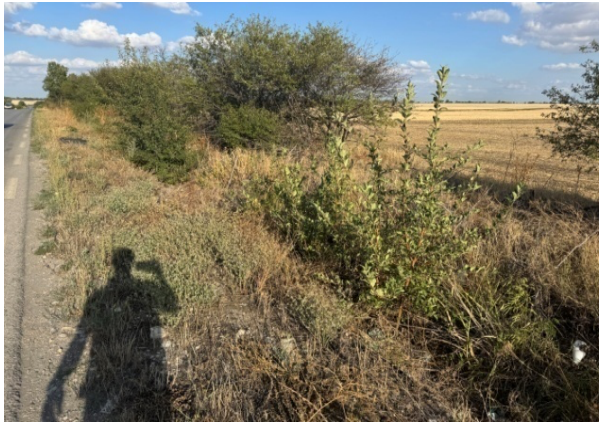
*Figure 34 – Condition of the shoulder – right traffic lane in the direction of travel (town Byala Slatina → town Knezha).*

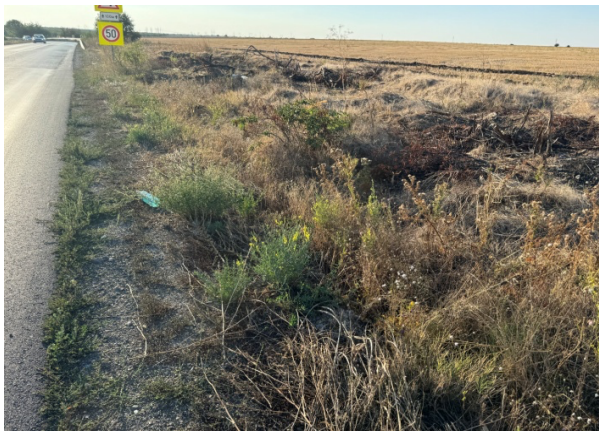
*Figure 36 – Condition of the shoulder – right traffic lane in the direction of travel (town Knezha → town Byala Slatina).*

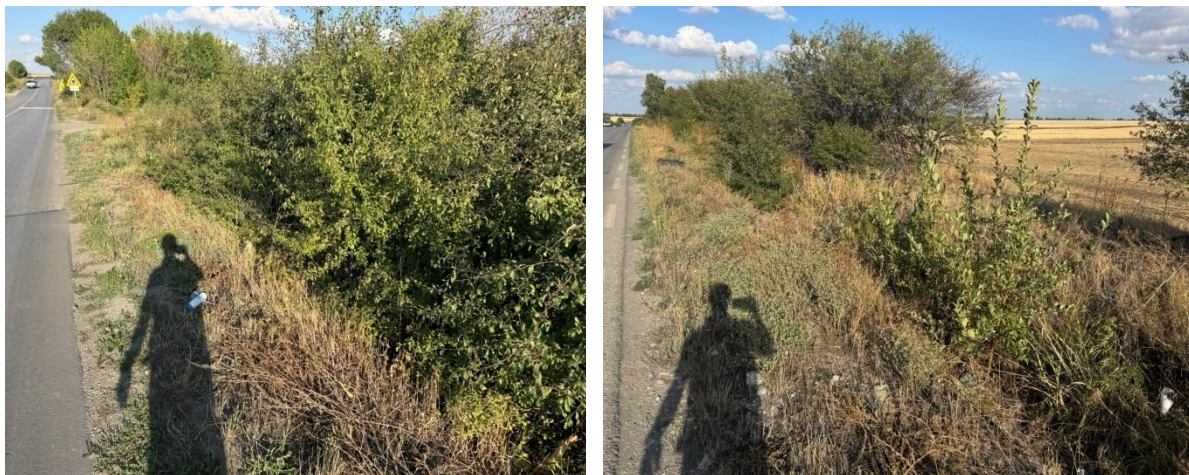
Figure 38 – Condition of the slopes in the studied section (direction from town Byala Slatina to town Knezha).

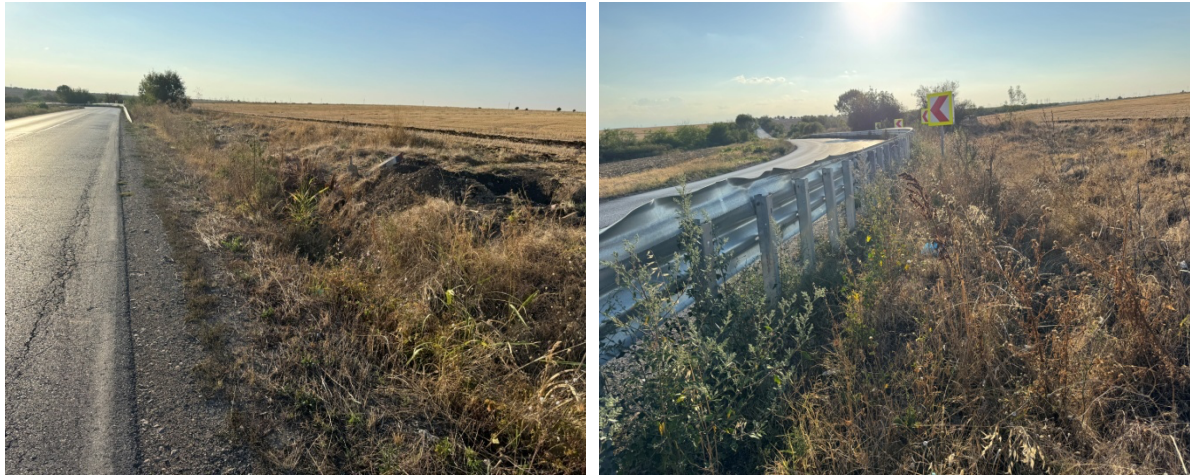
*Figure 39 – Condition of the slopes in the studied section (direction from town Knezha to town Byala Slatina).*

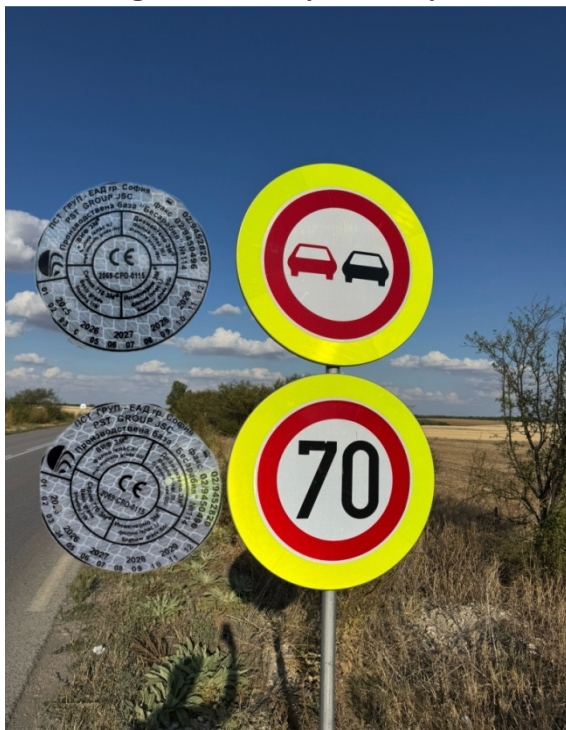
Road signs B24+B26 (70 km/h) at km 65+440 (new project) have different retroreflectivity classes. In Appendix No. 11 to Art. 6, para. 11, item 1 and Art. 10, para. 2 of Ordinance No. RD-02-21-1-PZ, the minimum classes for the coefficient of retroreflection are defined. With regard to road signs installed on the right side of a 2nd class road from road marking materials, the requirement is that they cover at least RA2. The class of the retroreflective surface of sign B24 corresponds to class RA2, while that of sign B26 (70 km/h) complies with R3A and R3B. The different classes of the retroreflective surface lead to drivers perceiving the sign with the lower class significantly later than the one with the higher class. This results in slower perception of the sign's instructions and delayed reaction or incomplete assessment of road conditions by road users.

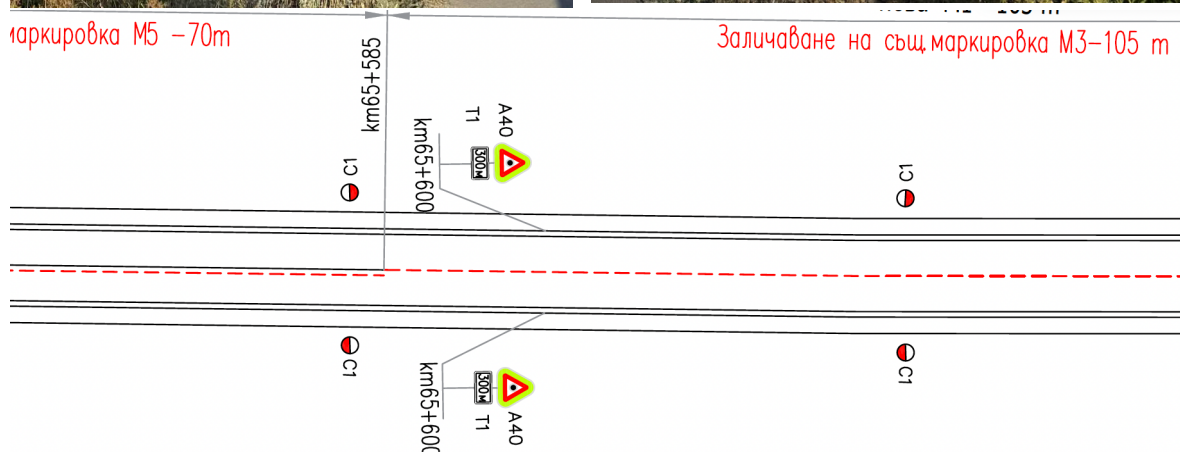
Road signs A40+T1 (300 m) are located at km 65+600 according to the new PPBD project for the UKPTP. Sign A40 – “Caution! Section with concentration of road traffic accidents”, which is located 300 m before the UKPTP (right side), is damaged and deformed. The retroreflectivity class of the surface of sign A40 complies with R3A and R3B, while plate T1 (right side) meets the requirements of RA2. Here again, an imbalance is created with regard to visibility of the road signs at night and under poor weather conditions. At one and the same location, road signs with the same retroreflectivity class must be installed, in order to guarantee that road users will be able to see and recognize in time the instructions of all road signs within the road scope.

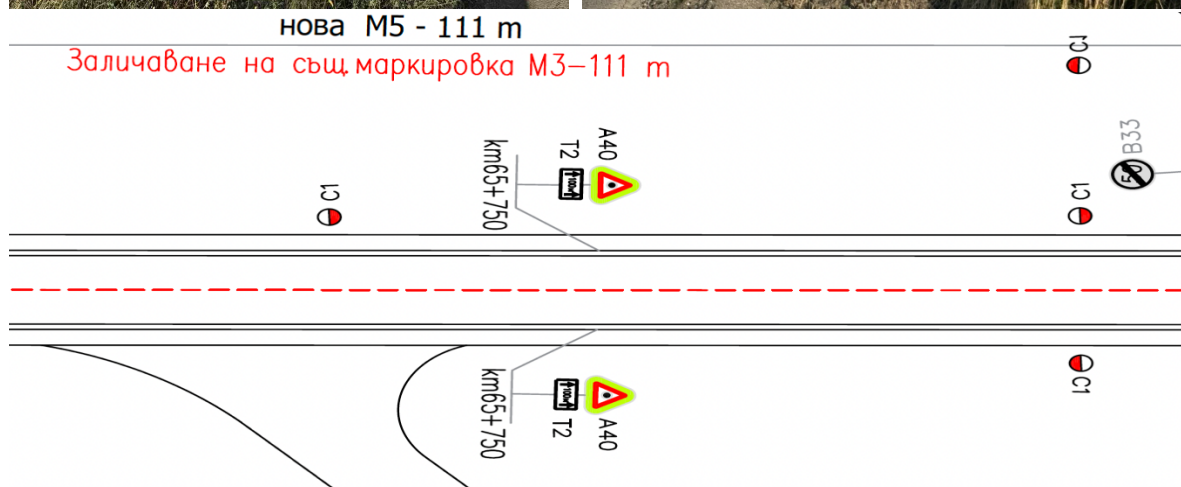
Road signs A40+T2 (100 m) are located at km 65+750 according to the new PPBD project for the UKPTP. The retroreflectivity class of the surface of sign A40 – “Caution! Section with concentration of road traffic accidents” meets the requirements of R3A and R3B, while plate T2 (right side) meets the requirements of RA2. Here again, an imbalance is created with regard to visibility of the road signs at night and under poor weather conditions. At one and the same location, road signs with the same retroreflectivity class must be installed, in order to guarantee that road users will be able to see and recognize in time the instructions of all road signs within the road scope.

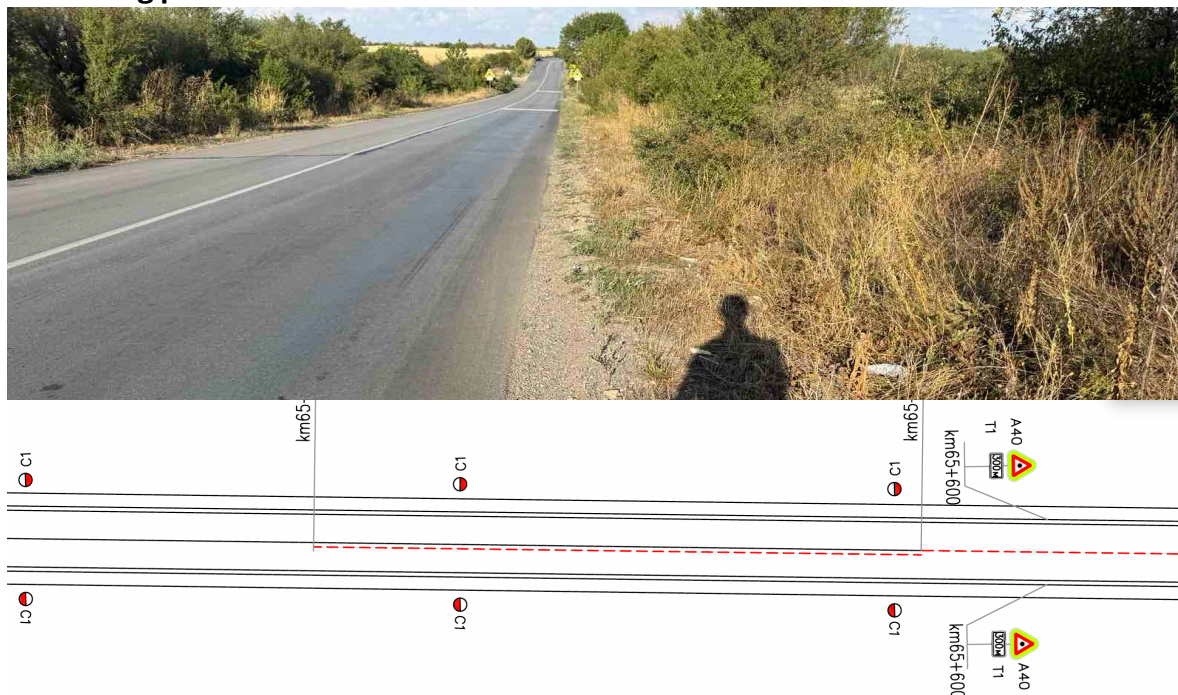
The project provides for the installation of guiding posts C1. During the inspection, not a single guiding post was identified. Even after the implementation of safety measures for the section, although they are provided for in the PPBD for the UKTP (new project), such posts were not installed. Their absence represents a serious deficiency, especially considering that there is no marking for the edge line of the road. In this manner, it becomes difficult for drivers to orient themselves regarding the boundaries of the traffic lane and the carriageway at night and under poor weather conditions.

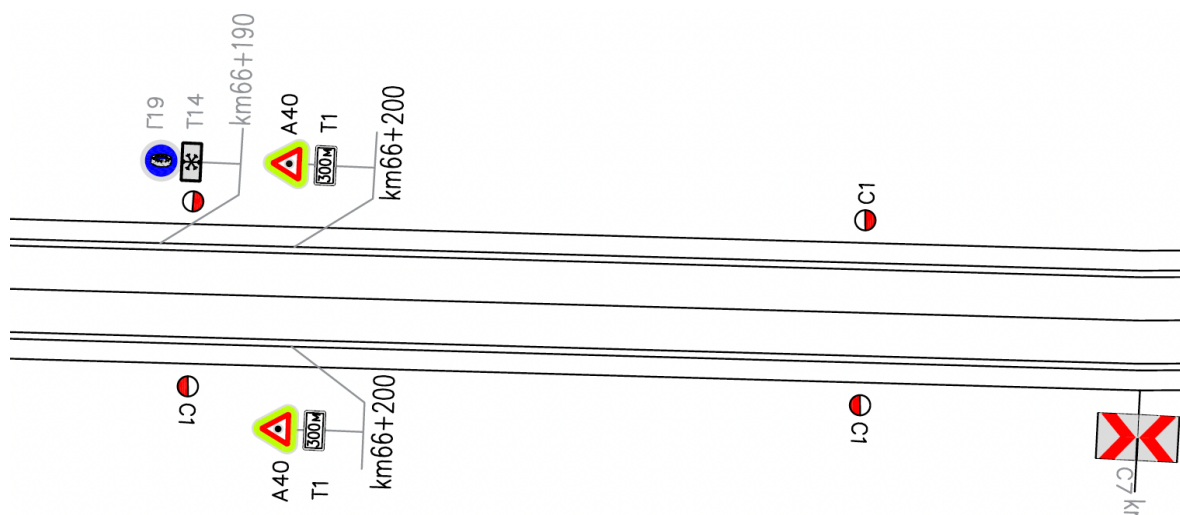
Road signs A40+T1 (300 m) are located at km 66+190 on the north side of the traffic lane according to the new PPBD project for the UKPTP. Sign A40 – “Caution! Section with concentration of road traffic accidents” has a retroreflectivity class of the surface corresponding to R3A and R3B, while plate T1 (right side) meets the requirements of RA2. Here again, an imbalance is created with regard to visibility of the road signs at night and under poor weather conditions. At one and the same location, road signs with the same retroreflectivity class must be installed, in order to guarantee that road users will be able to see and recognize in time the instructions of all road signs within the road scope.

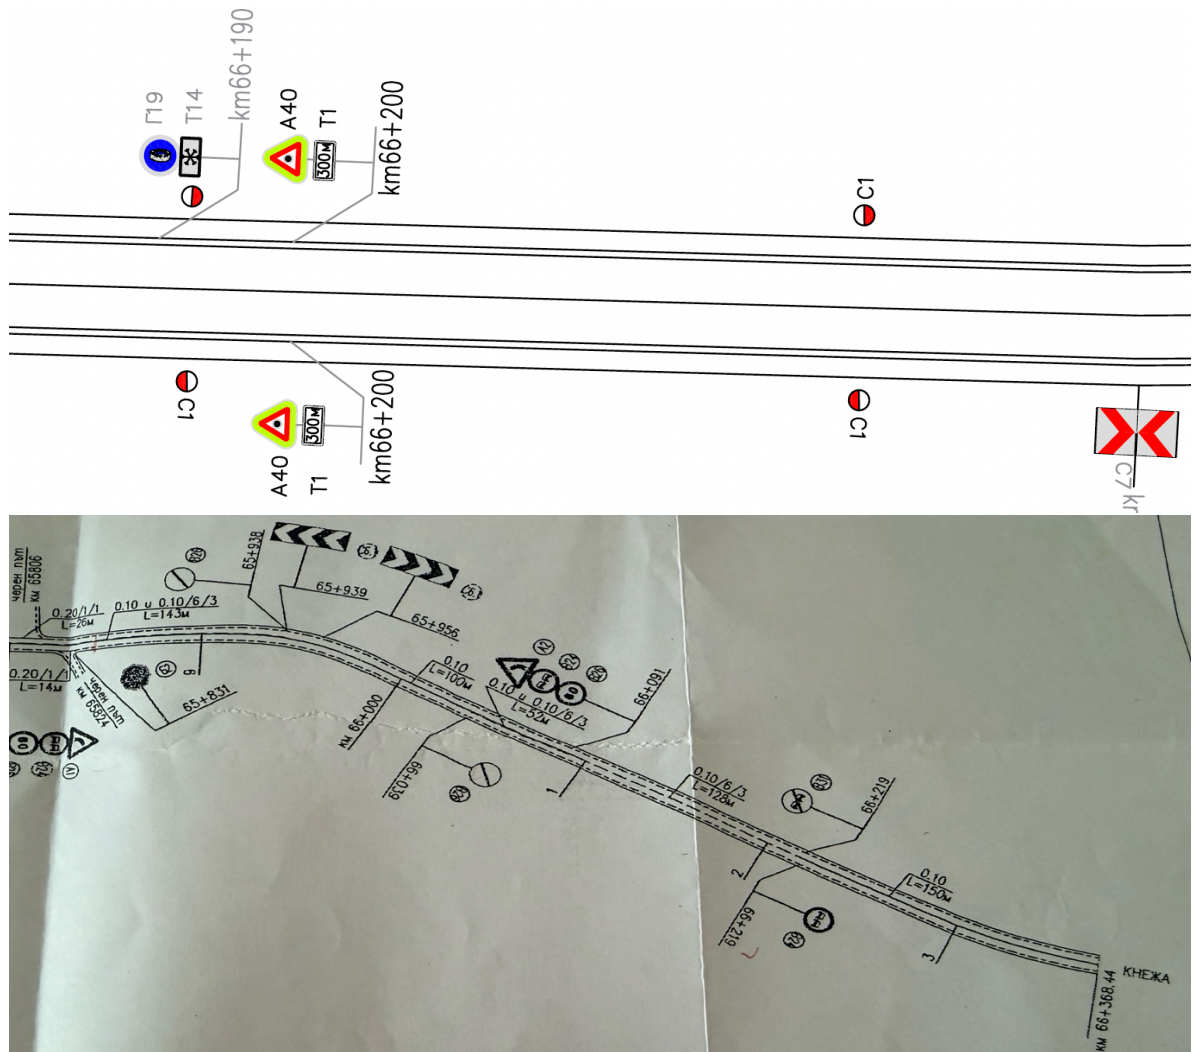
Road sign G19 cannot be used in combination with supplementary plate T14, in accordance with the current requirements of Ordinance No. RD-02-21-1-PZ. Sign G19 is used in accordance with the conditions and under the procedure of Art. 103 of Ordinance No. RD-02-21-1-PZ. In Art. 190 of Ordinance No. RD-02-21-1-PZ, it is determined when, where and in combination with which other road signs supplementary plate T14 “In snow and winter conditions” may be used.

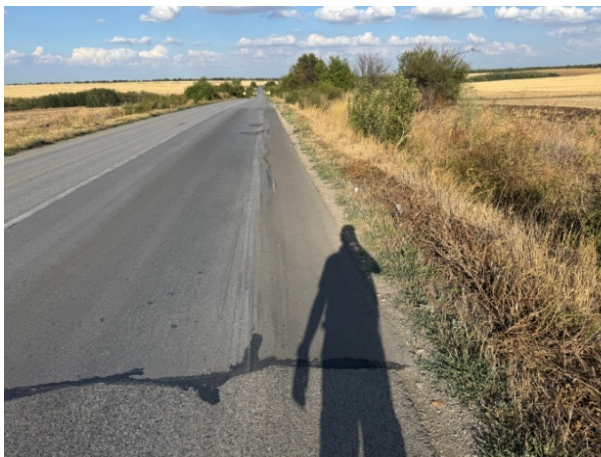
Figure 47 – Condition of the edge line marking the boundary of the carriageway (right lane, direction from town Byala Slatina to town Knezha). The photo was taken in September 2025 after the safety measures for the UKTP were implemented.

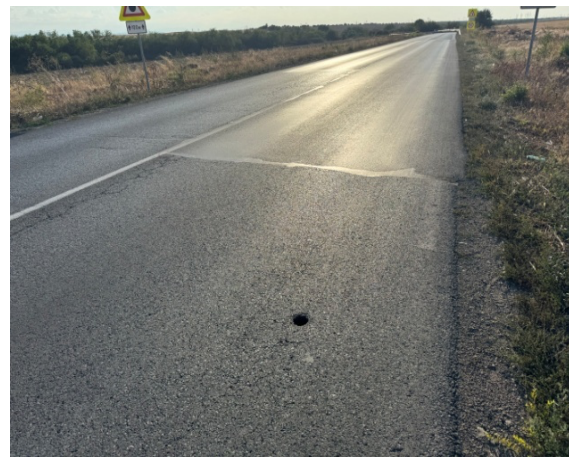
Figure 48 – Condition of the edge line marking the end of the carriageway (right lane, direction from town Knezha to town Byala Slatina). The photo was taken in September 2025 after the safety measures for the UKTP were implemented.

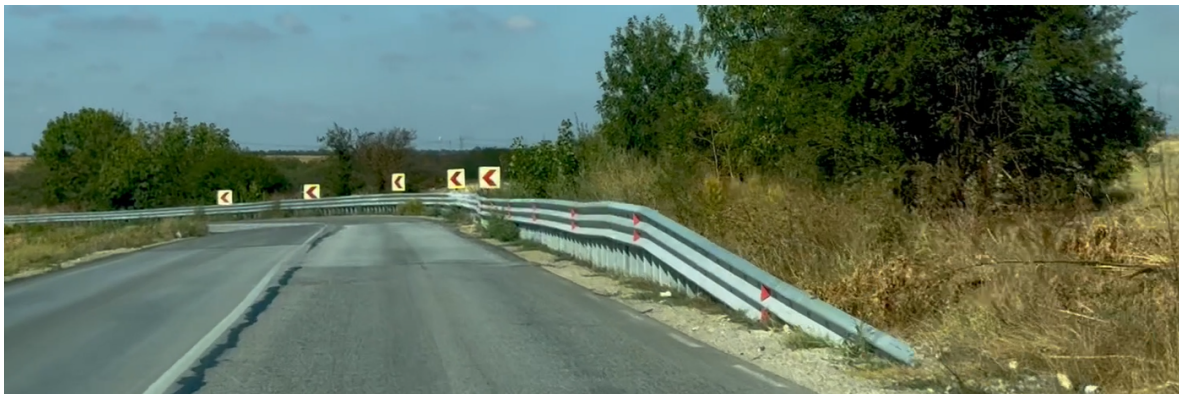
Figure 61 – Initial element of road restraint system at km 66+010 (direction of travel from town Knezha to town Byala Slatina) before the safety fence, which does not comply with the requirements of point 2.2 “Execution of initial and final elements of road restraint systems” to Ordinance No. RD-02-20-1-RRS. It must be replaced with a single terminal.

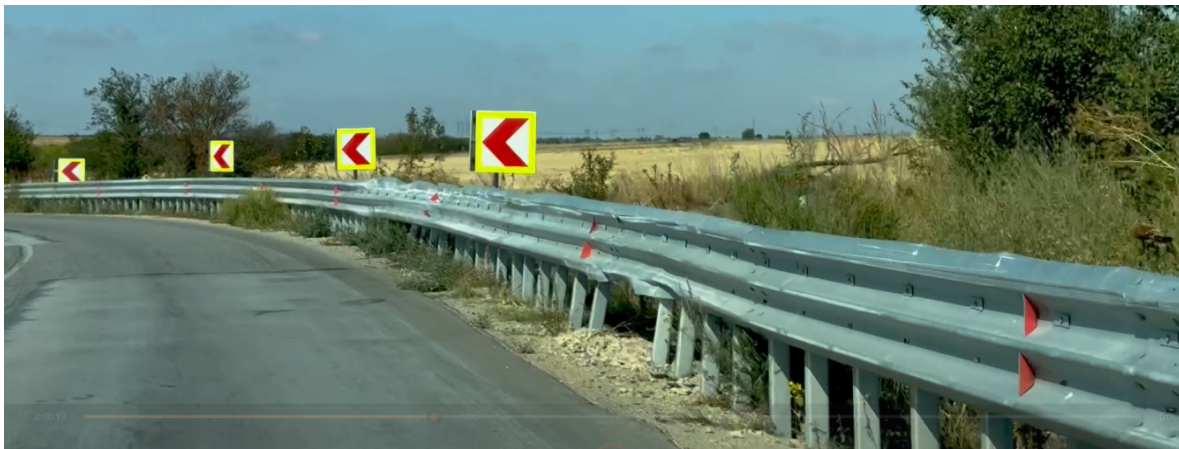
Figure 62 – Damaged road restraint system as a result of a road traffic accident, located on the right side of the left curve in the direction of travel from town Knezha to town Byala Slatina.

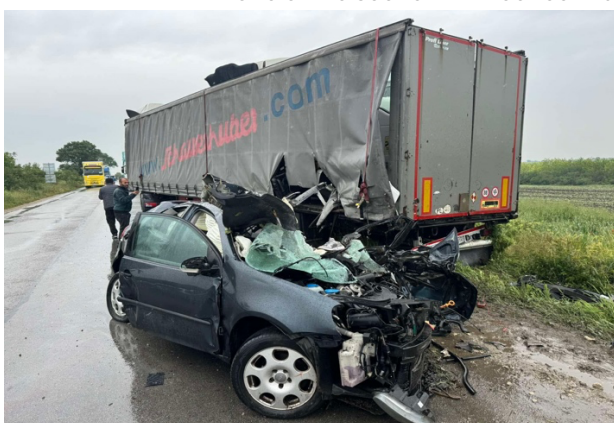
Figure 65 – Condition of the passenger car involved in a serious road traffic accident at km 65+920, which was crushed against the road restraint system by the trailer of an oncoming heavy goods vehicle traveling in the direction from town Byala Slatina to town Knezha. The road accident ended with three injured.

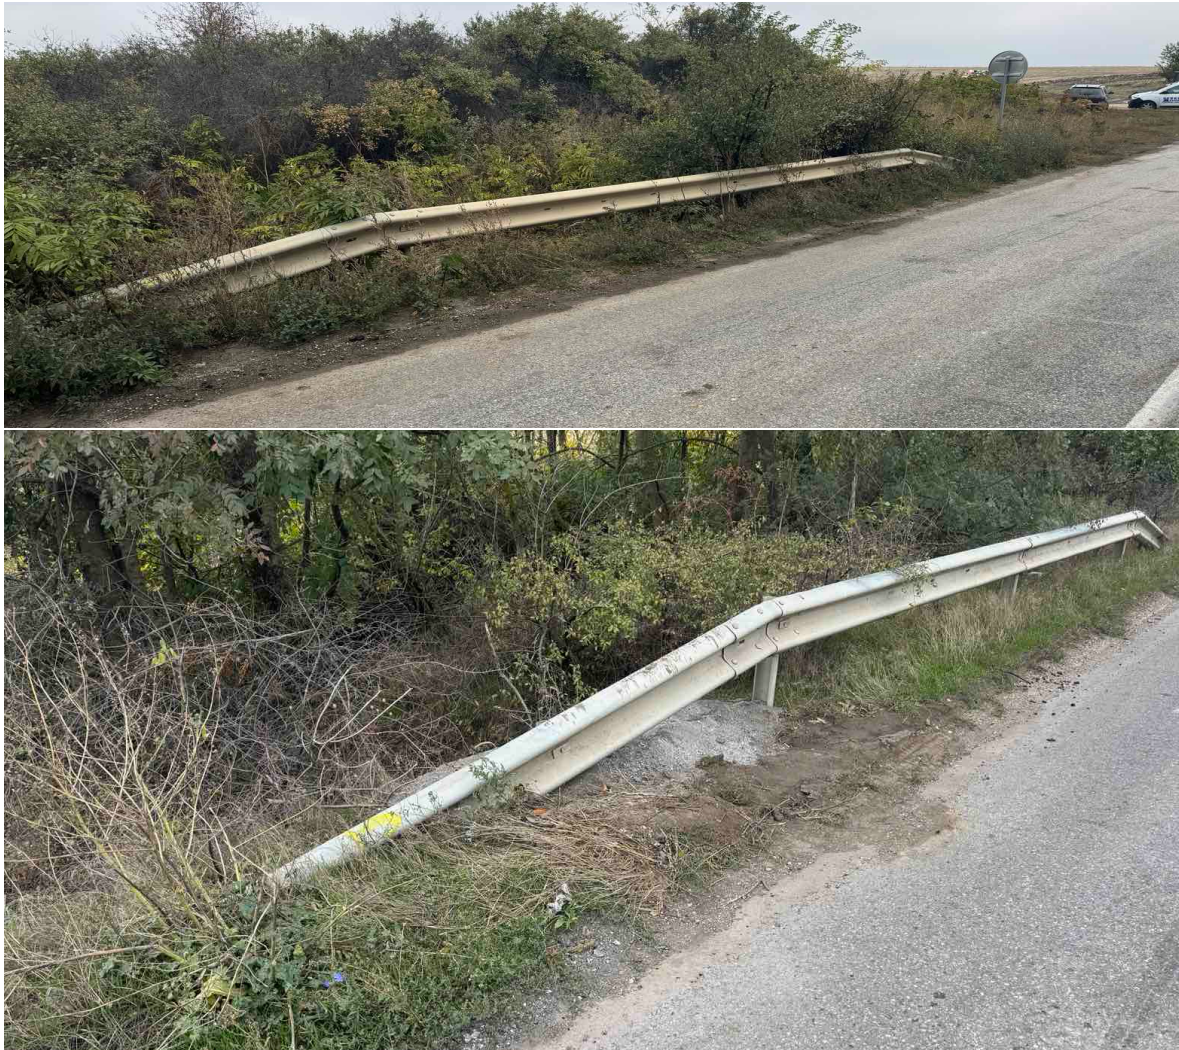
*Figure 71 – Condition of the road restraint system on both sides of the culvert located at km 65+770.*

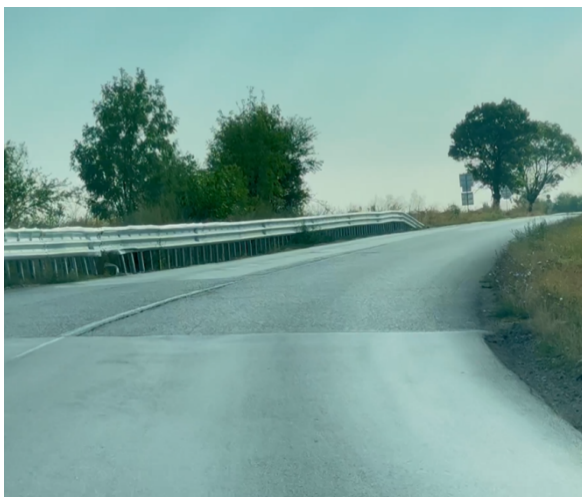
*Figure 76 – Condition of the asphalt pavement in the curve.*

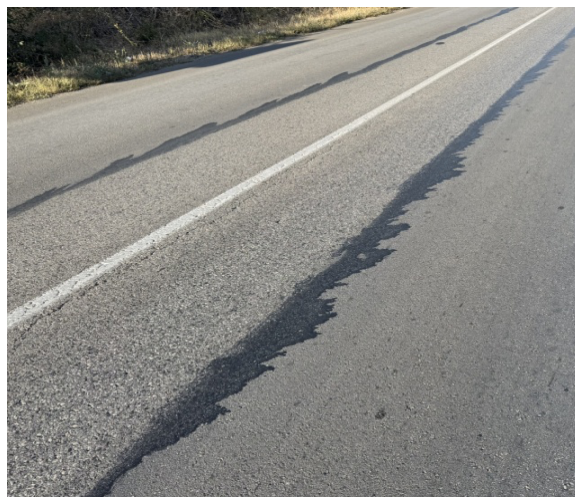
*Figure 77 – Difference in the aggregate grading between the old and the new asphalt. The old grading is Type B, while the new grading is Type A.*

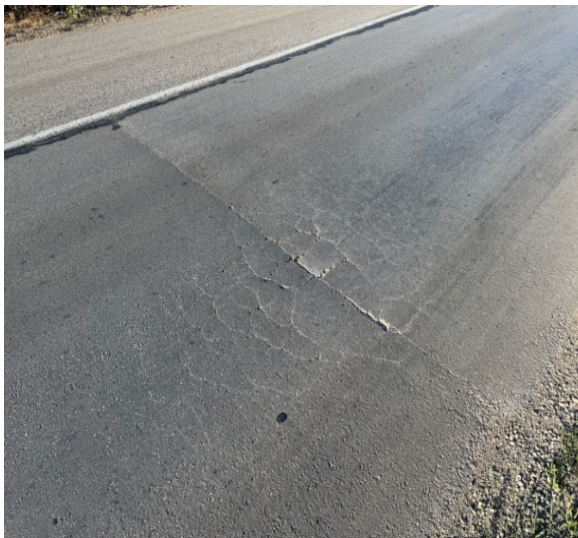
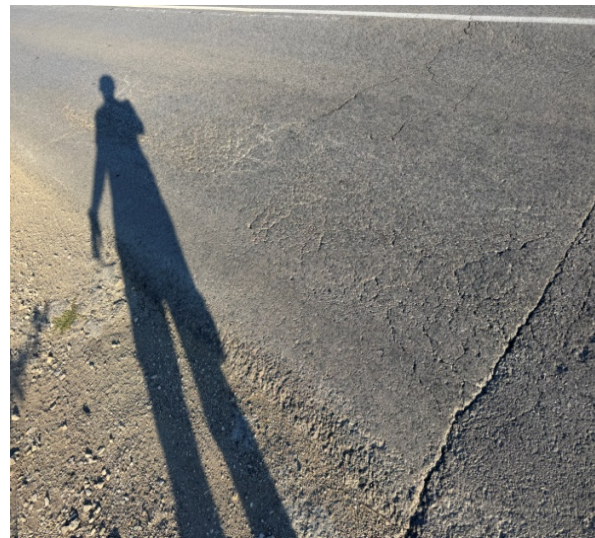
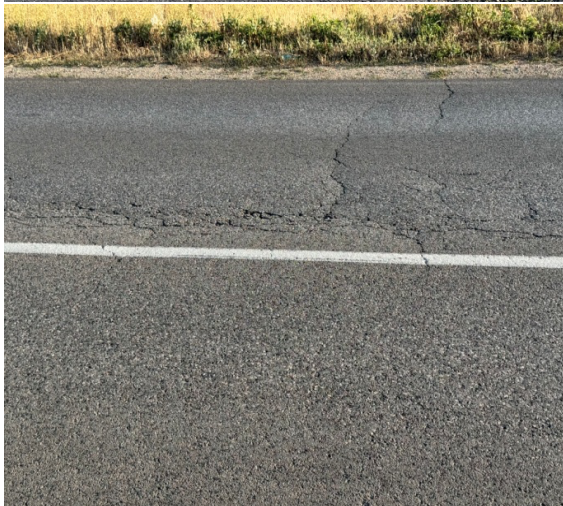
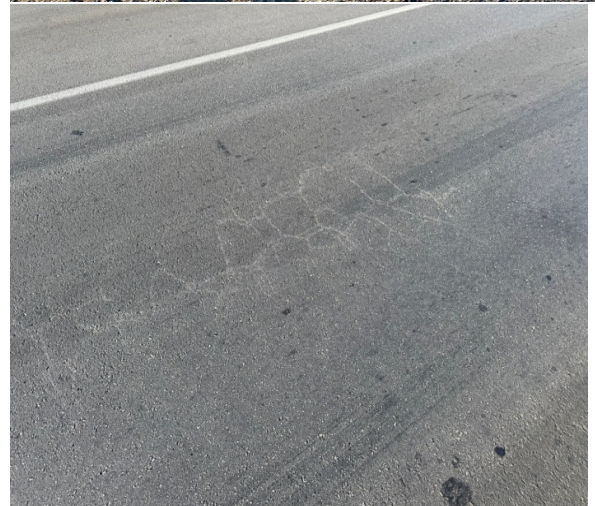
*Figure 78 – Presence of mesh-like and block cracks in numerous zones.*

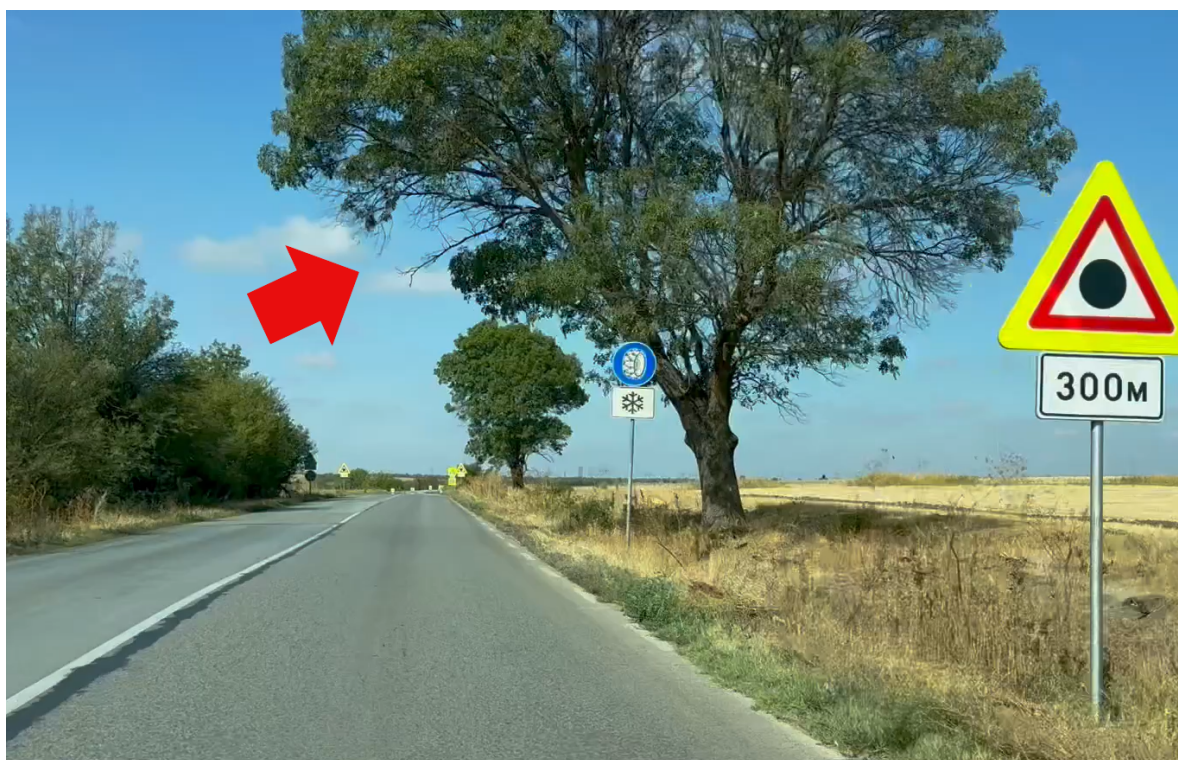
*Figure 82 – On-site, a tree was identified with dried branches extending over the traffic lane.*
