## REPORT

Targeted Road Safety Inspection on Road II-13 in a Section with Concentration of RTAs from km 65+440 to km 66+200

12 August 2025 / from 17:30 to 18:30 GMT +3

**Final Report**

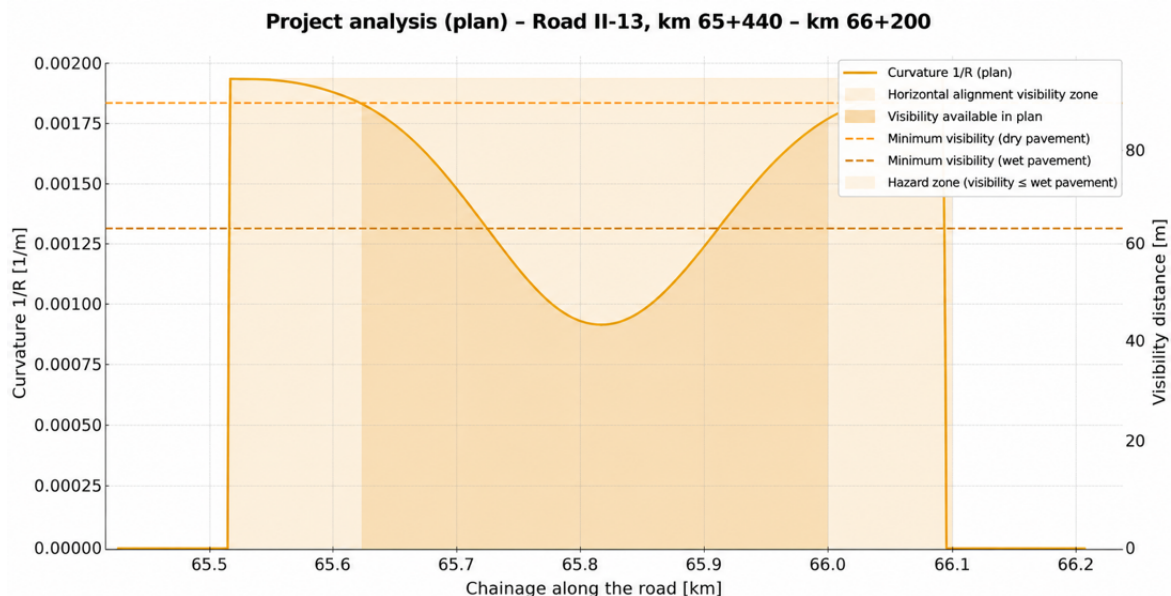
Figure 3 – Analysis of the plan projection – Road II-13 from km 65+440 to km 66+200.

The danger points in plan are: the curve entry (short preceding straight, risk of unprepared entry), the apex (limited side visibility from the inner strip vegetation/ditch) and the exit (transition to a longer straight where drivers often accelerate prematurely). These locations coincide with the zones where we have already identified insufficient stopping sight distance under wet conditions.

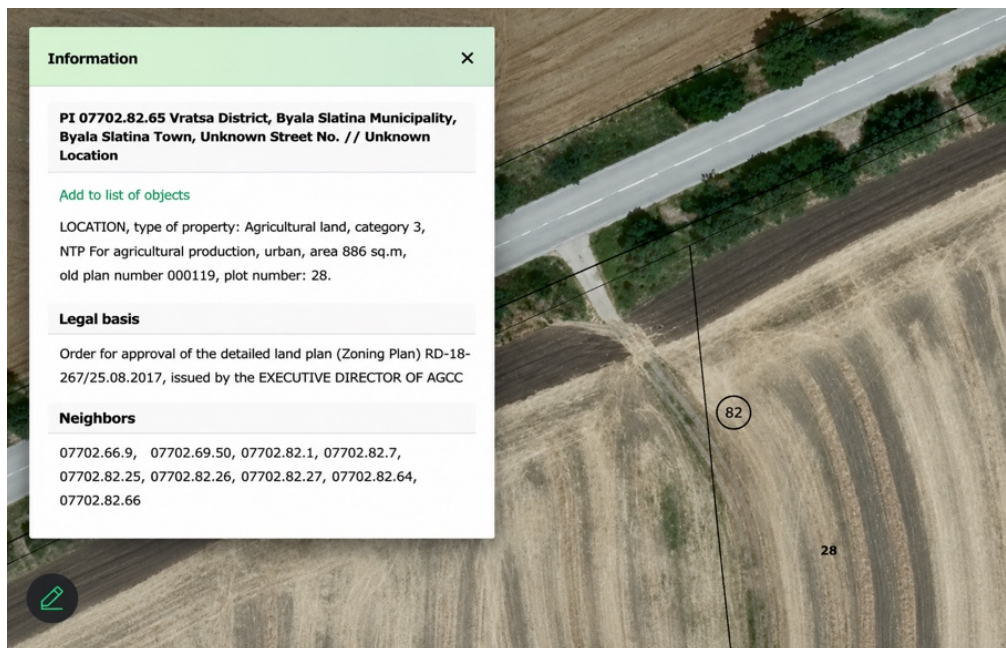
Figure 4 – Inquiry from CAIS for property with identifier 07702.82.65.

Parallel to the alignment of Road II-13 (representing a property with identifier 07702.66.9), runs a property with identifier 07702.82.65, representing an area designated for agricultural/ forest/ departmental road. In CAIS there is no information about a designated area representing a perpendicular connection to the main direction of the republican road.

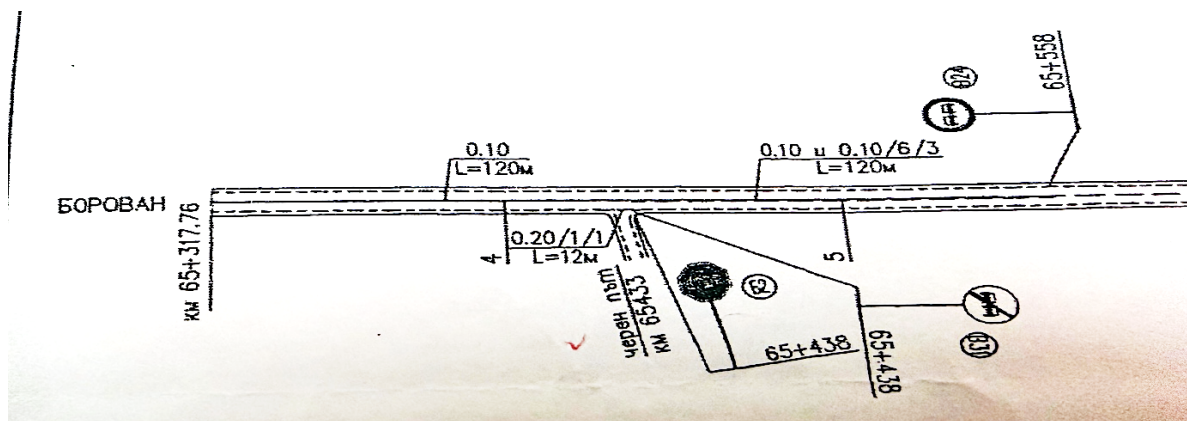
Figure 5 – An excerpt from the PPBD (old project) reflecting the presence of road sign B2 at km 65+438, sign B31 at km 65+438, and on the opposite side sign B24 at km 65+558. None of these signs is currently installed within the road scope.

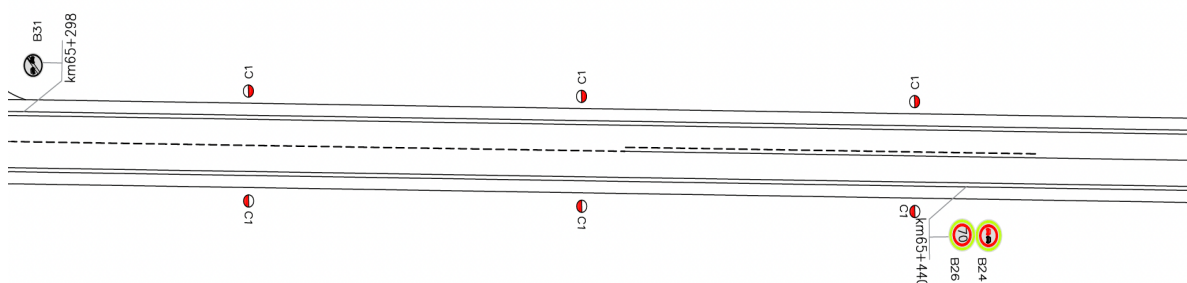
Figure 6 – An excerpt from the PPBD for the UKTP (new project): sign B31 at km 65+298 to sign B24+B26 at km 65+440 (there is a discrepancy between the actual location of the road signs and their location according to the PPBD). The unregulated intersection is located approximately between the second guiding post C1 and the third from the PPBD excerpt, in the direction of travel from village Borovan to town Knezha.

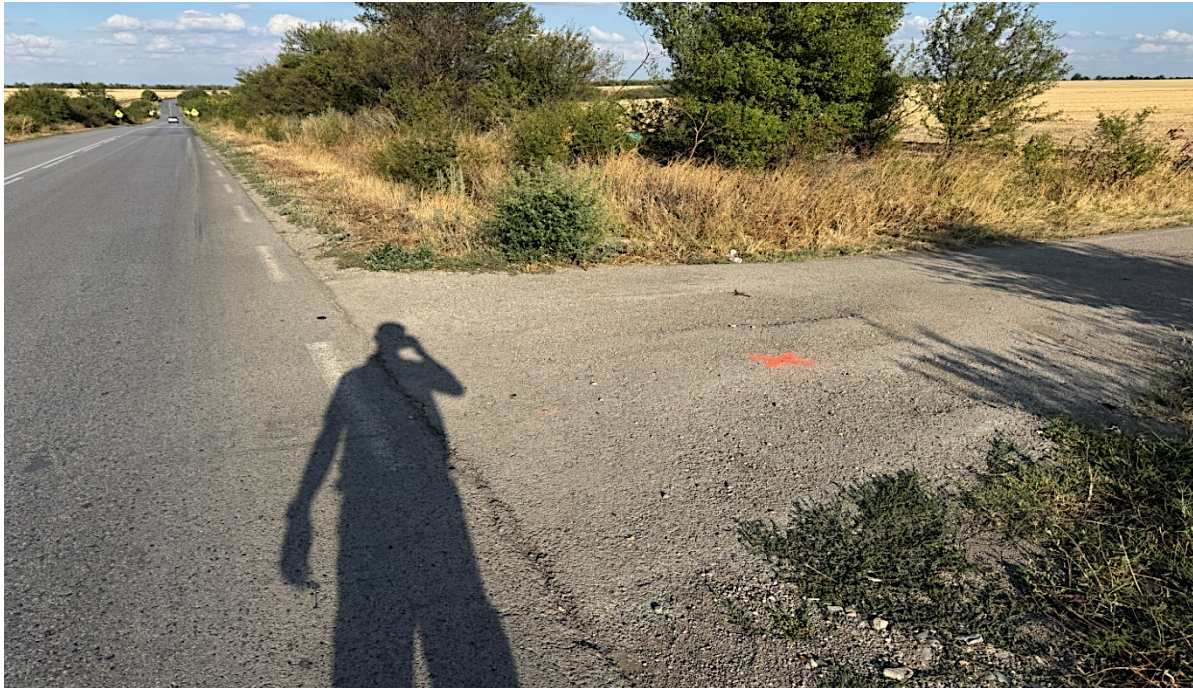
*Figure 7 – Unmarked agricultural/forest road, located on the right side of the traffic lane in the direction from town Byala Slatina to town Knezha, at the beginning of the inspected section.*

During the on-site inspection, it was established that a crossing with an agricultural/ forest/ departmental road actually exists; although this connection is unregulated, it is even asphalted. A significant problem is also the uncleared vegetation, which substantially obscures and limits the field of visibility.

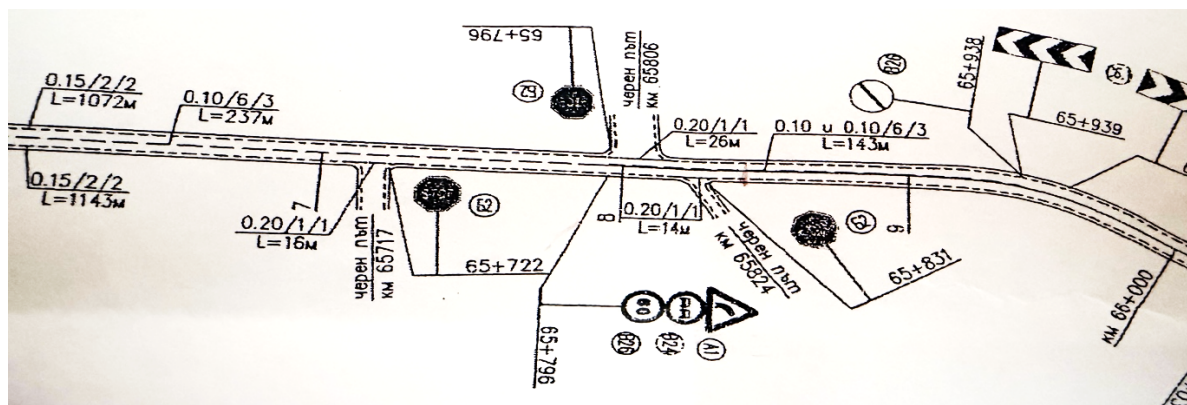
Figure 8 – Excerpt from the old project (12/2007, sheet 05-005-0), on which road sign B2 is planned at km 65+722.

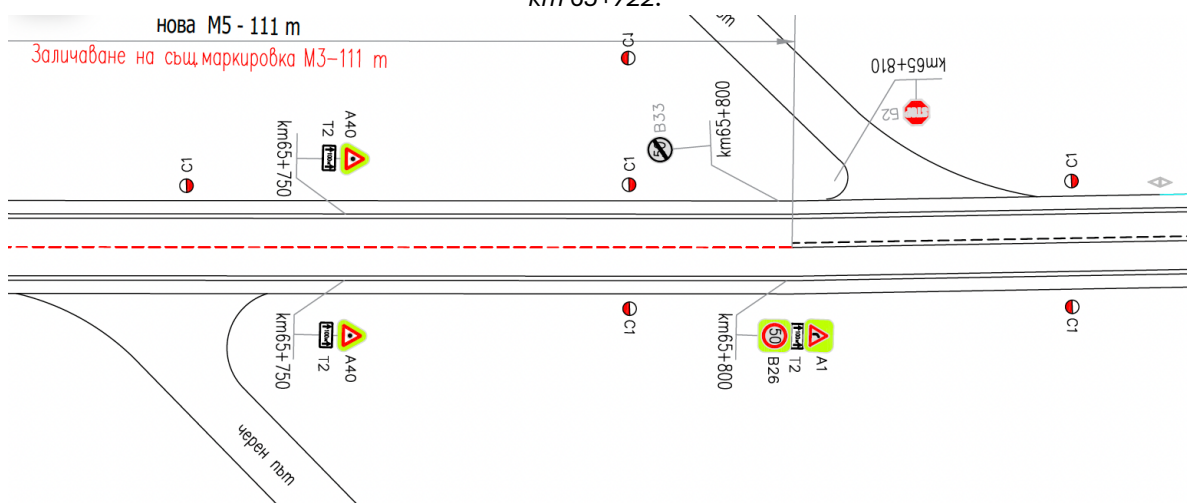
Figure 9 – Excerpt from the PPBD for the UKPTP (new project), on which it is visible that the unregulated dirt road is marked. The project does not reflect that sign B2 is missing, as it is in the old project. This road should have been closed with the design solution for securing the section with a concentration of road accidents.

There are significant discrepancies between the old and new PPBD projects. The two projects are independent of each other and in no way do they complement one another. The PPBD for the UKPTP should complement the existing project. In this case, the two even contradict each other to a certain degree. The old road signs that should be removed are not marked.

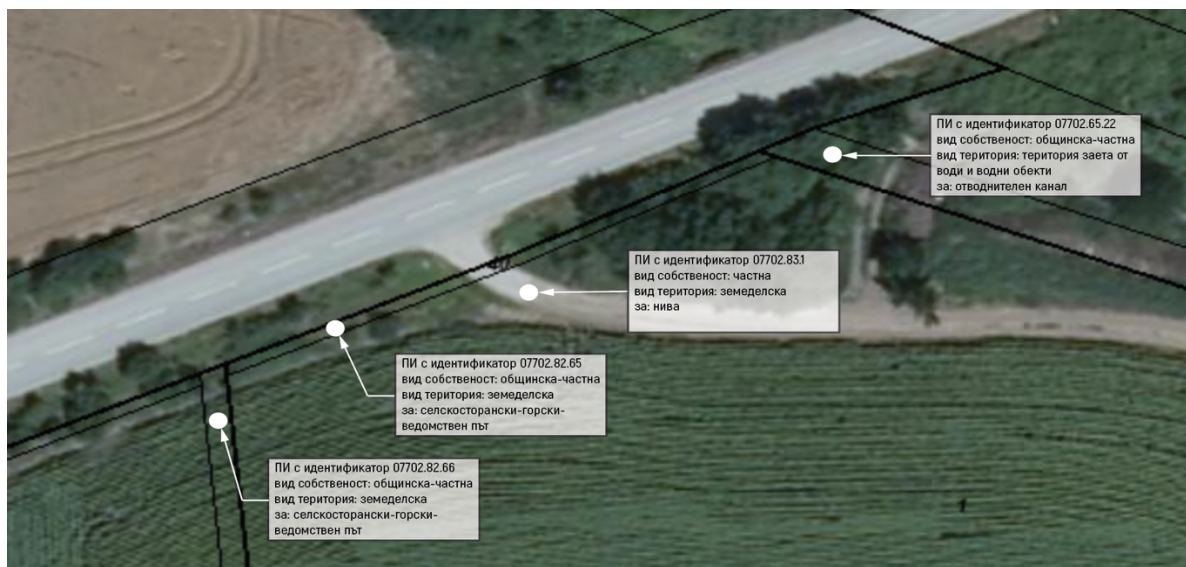
Figure 10 – CAIS excerpt with precise definition of the types of territories and purpose of the different properties.

In accordance with the requirements of the Roads Act, within the road scope, no objects may be constructed or used that are not related to its service, maintenance or traffic safety, without permission from the administration managing the road. Therefore, the presence of an unregulated road approach represents an unauthorized intervention in the scope of a republican road, which must be removed or physically restricted by construction of an earth embankment, protective fence or road restraint system. Furthermore, the designer was obliged to provide a controlled service connection to the side network if there had been a real need for access to agricultural properties, rather than leaving an open unregulated alignment that compromises overall road safety.

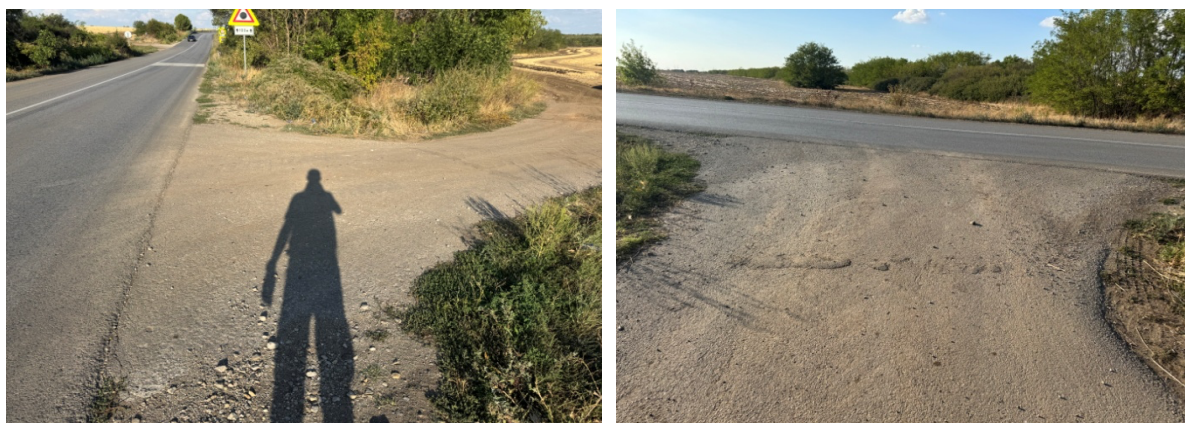
Figure 11 – Established the presence of asphalt pavement at the turn-off for the agricultural/forest road and the absence of road sign B2 on the right side in the direction from town Byala Slatina to town Knezha.

Another substantial omission is the absence of warning road signs A27 and A28, indicating respectively “intersection with a road without priority”. In this manner, drivers traveling on the main direction are not warned of the possible entry from a dirt road, while drivers exiting from it have no visual information about the nature of the connection and their obligation to yield to traffic. This is a direct violation of Ordinance No. RD-02-21-1 of 23 November 2023 on road signing with road signs. The principle established in this subordinate regulatory act is that before every location of merging or crossing of roads, the respective warning signs shall be installed, especially when visibility is limited or traffic is intensive.

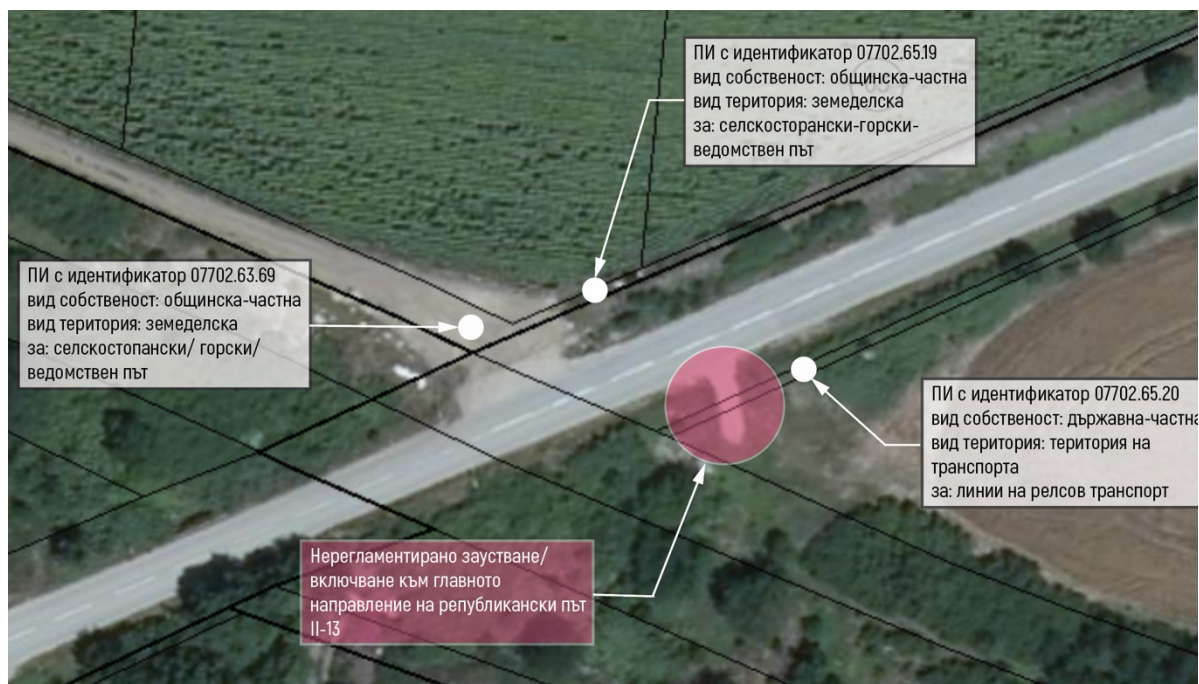
Figure 13 – CAIS inquiry reflecting the type of ownership, type of territory, purpose and number (identifier) of the property.

On the south side of the traffic lane, running parallel, is a property with identifier 07702.65.20, which has the purpose: “rail transport lines”, which currently does not exist there.

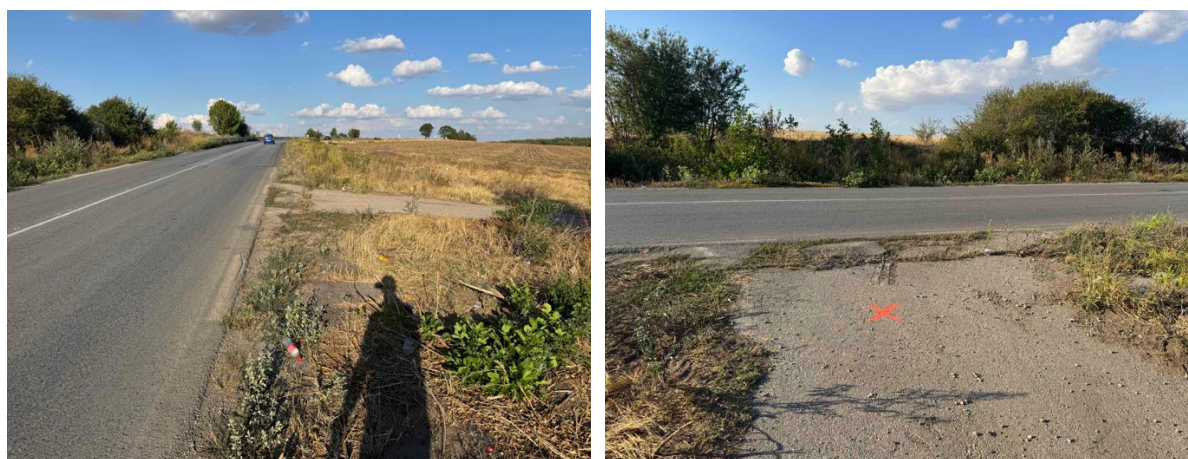
Figure 14 – Direct joining of an unregulated dirt road to the alignment of republican road II-13. In the PPBD (old project), the installation of road sign B2 was planned for this road (at km 65+831), while the dirt road is located at km 65+824.

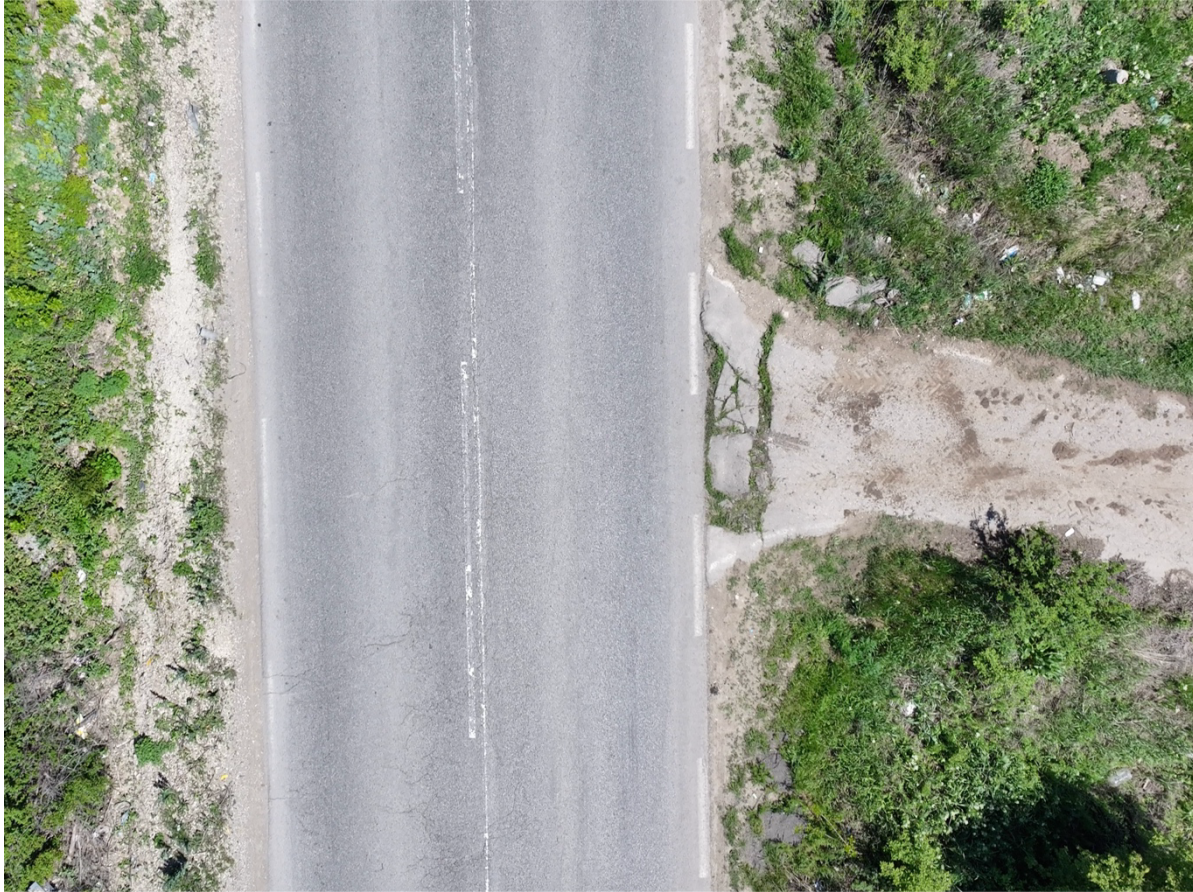
Figure 15 – Unregulated connection at km 65+824. Excerpt from surveying by the remote sensing method in May 2025, performed by the EUCTP team.

Upon comparison between the old PPBD project and the new PPBD project for the UKPTP, a discrepancy was established. In the old project at km 65+824, a “dirt road” is marked and road sign B2 at km 65+831, while before this intersection there is no warning sign A26 “Intersection with a road without priority from both sides”. In the new project, the crossing from the south side does not exist. On-site inspection established that no road signs are installed – neither warning signs nor B2 – at the asphalted part of the dirt road (at its joining to the alignment of the main direction).

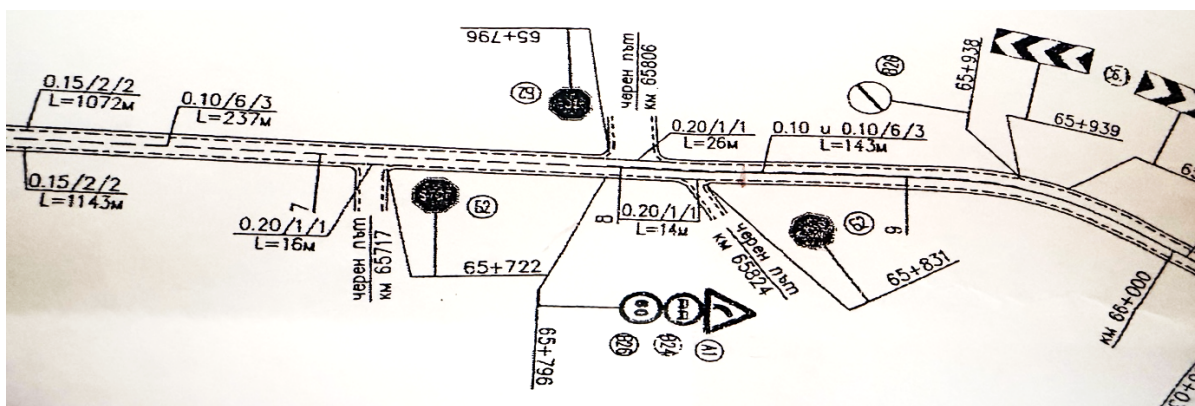
Figure 16 – Excerpt from the old project (12/2007, sheet 05-005-0), on which road sign B2 is planned at km 65+831.

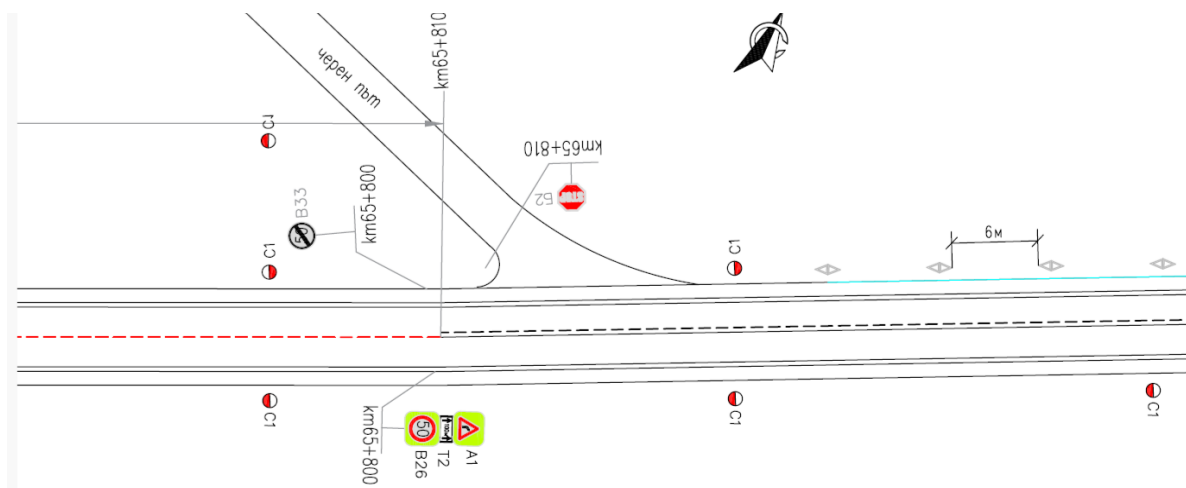
Figure 17 – Excerpt from the PPBD for the UKPTP (new project), on which it is visible that the unregulated dirt road is not marked. The project does not reflect the presence of sign B2, as it is in the old project. This road should have been closed with the design solution for securing the section with a concentration of road accidents.

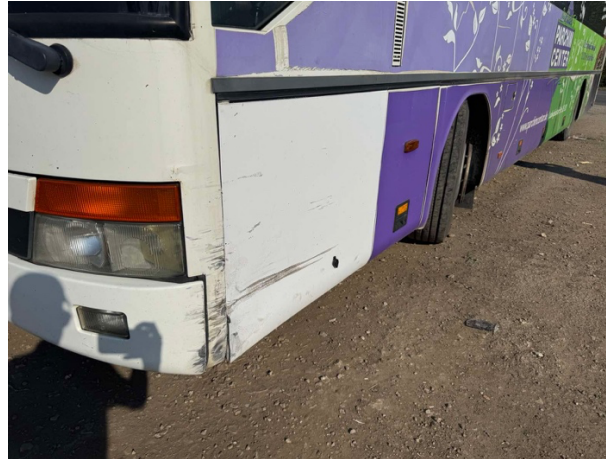
Figure 20 – Photo of the bus involved in the accident.

In zones that represent sections with a concentration of road traffic accidents, it is necessary to approach unregulated connections with particular caution. Every unmarked possibility for joining the main alignment represents a risk, and every risk leads to error. Unregulated connections must be closed, while others must be marked in the appropriate manner with road signs and road markings.

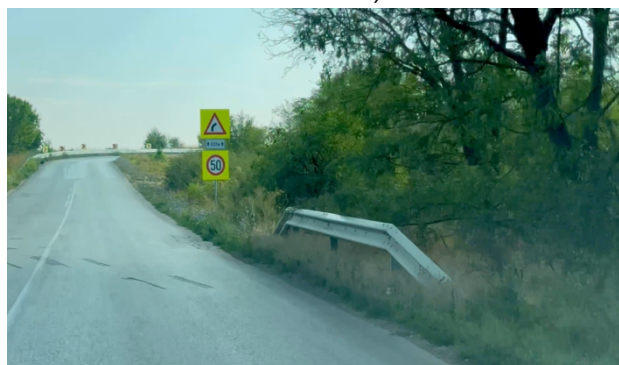
Figure 29 – Example of vegetation clearing behind the road maintenance base – right traffic lane in the direction of travel (town Byala Slatina → town Knezha).

In the sections where road restraint systems are present, clearing is done only up to the beginning of the restraint system, while behind and beneath it no effort whatsoever has been made to remove shrubs and grass. This creates a number of problems, one of which has already been mentioned with regard to drainage of water from the traffic lane. The tall grass and shrubs also obscure the restraint system and contribute to the destruction of its structural integrity. The tall grasses and shrubs also obscure the retroreflective elements C14.1. In some places, the C14.1 elements themselves are completely missing.

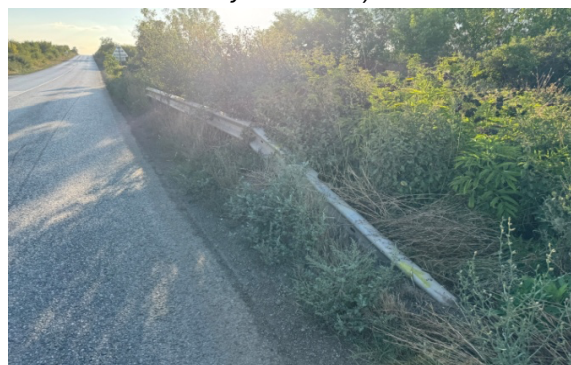
Figure 30 – Example of vegetation clearing behind the road maintenance base – left traffic lane in the direction of travel (town Knezha ← town Byala Slatina).

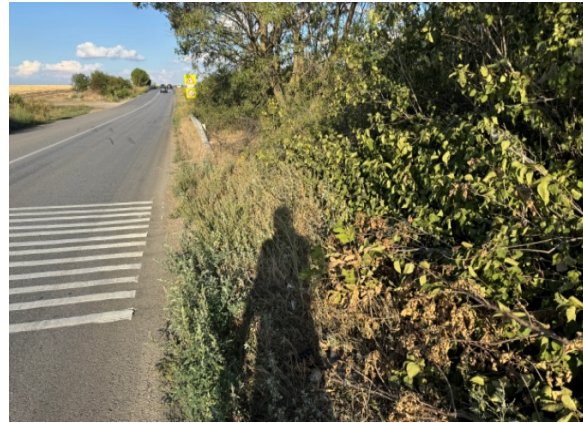
A substantial violation of Article 136, paragraphs 1 and 2 of the “Technical Rules and Requirements for Road Maintenance by the Road Infrastructure Agency” has been

*Figure 35 – Condition of the shoulder – right traffic lane in the direction of travel (town Byala Slatina → town Knezha).*

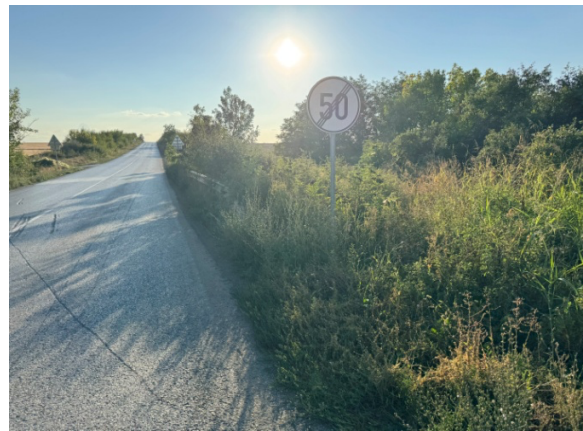
*Figure 37 – Condition of the shoulder – right traffic lane in the direction of travel (town Knezha → town Byala Slatina).*

The vegetation retains moisture, while roots and erosion compromise the edge, and heavy goods vehicles and peripheral movement during passing critically load this zone. The problem is further intensified where there are unregulated connections from agricultural/forest roads. Heavy agricultural machinery when entering or exiting exerts a negative influence on the edge of the pavement and further intensifies erosion, which in turn compromises the remaining part of the traffic lane.

It is recommended to apply structural widening for edge reinforcement (including geogrid), milling and laying of a new wearing course with correction of cross slopes; review of the curve geometry (radius and superelevation) and use of SMA/HFST in the zones of high transverse forces.

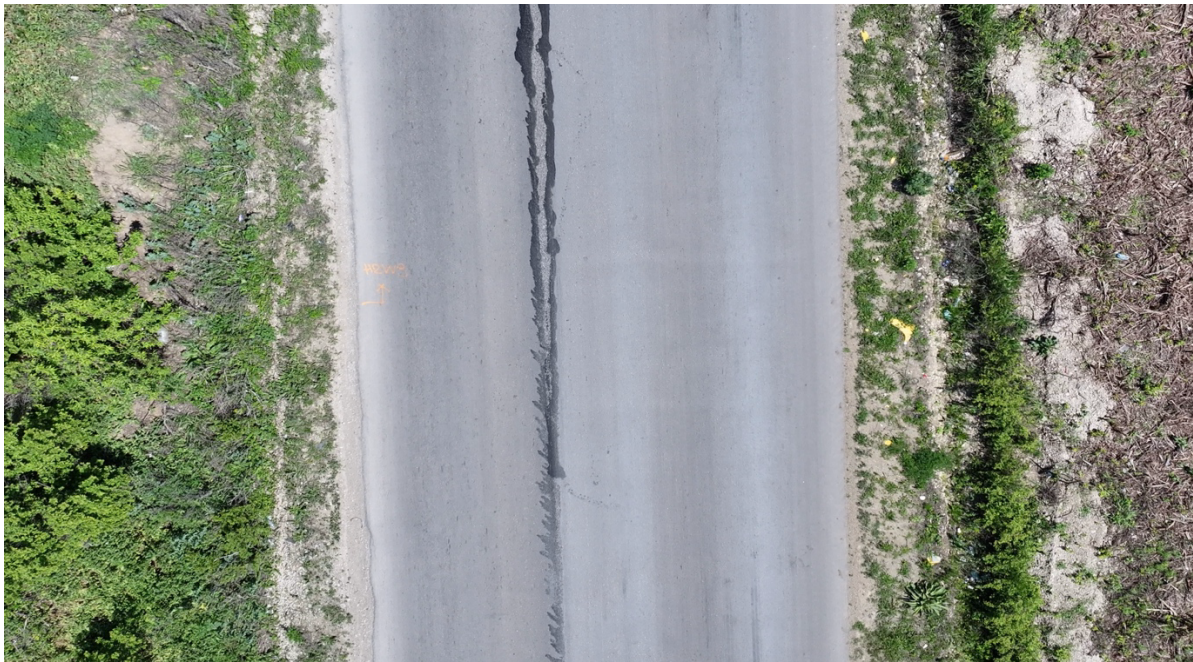
*Figure 40 – Condition of the slopes, visualization from surveying performed by the EUCTP team in May 2025 using the remote sensing method.*

From the above images, as well as during the inspection performed by the ECTP team, it was established that the slopes on both sides of the road pavement are in a compromised condition and do not meet the requirements for stability and a maintained visible profile. The left slope (with respect to the direction of travel – the direction from town Knezha to town Byala Slatina) is overgrown with vegetation, including shrub species and grass formations, which in places encroach into the shoulder and narrow the useful width of the road. This creates a risk for drainage and visibility, especially during passage of heavy goods vehicles.

The right slope (direction of travel from town Byala Slatina to town Knezha) shows partially eroded sections and exposed earth surface, which is a sign of absence of grass stabilization and increased risk of washout during rainfall. Along the edge of the pavement, absence of a formed shoulder is observed, which leads to an uneven

boundary between the pavement and the earth foundation and increases the probability of side slippages and damage to the asphalt edge.

Overall, the road corridor does not maintain the necessary cross-section – the slopes do not ensure stability, drainage and visibility in the lateral zone. No traces of regular clearing or mechanical shaping are noticeable. The condition indicates a need for profiling and strengthening of the slopes, clearing of vegetation, shaping of the shoulders with a longitudinal slope towards the ditch and application of erosion protection measures.

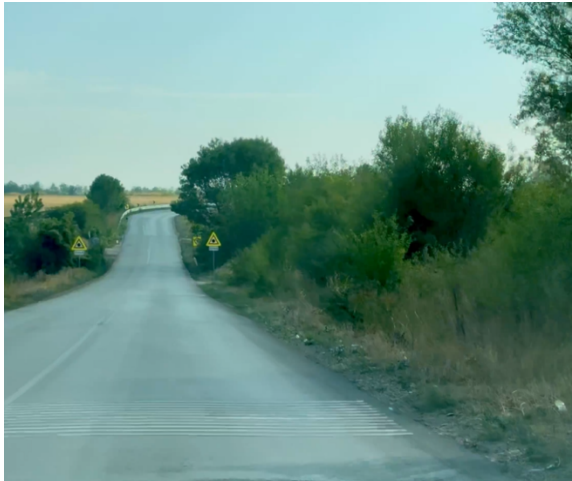
*Figure 41 – General view of the traffic lane in the direction from town Byala Slatina to town Knezha.*

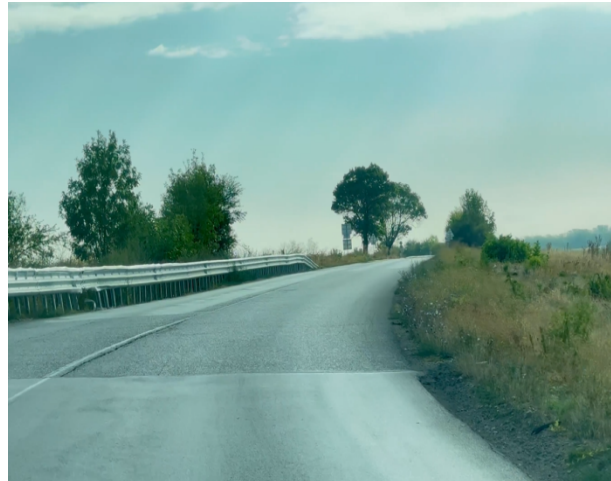
*Figure 42 – General view of the traffic lane in the direction from town Byala Slatina to town Knezha.*

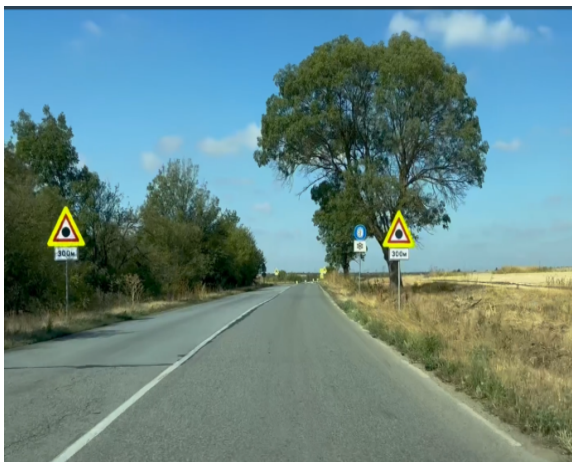
*Figure 43 – General view of the traffic lane in the direction from town Knezha to town Byala Slatina.*

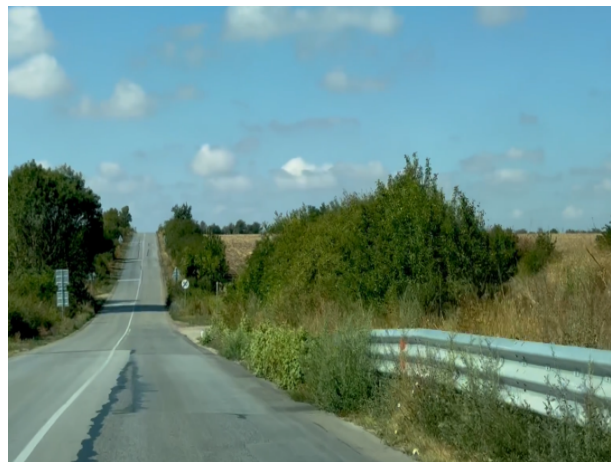
*Figure 44 – General view of the traffic lane in the direction from town Knezha to town Byala Slatina.*

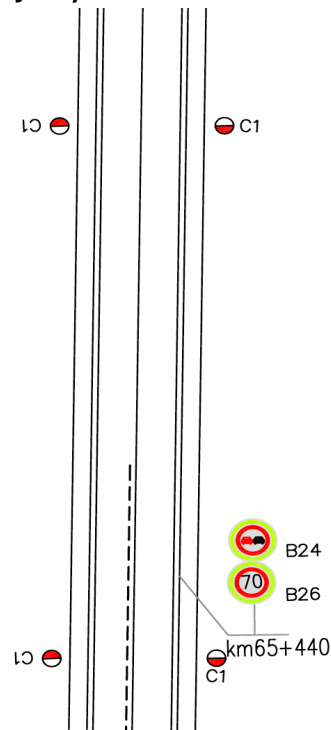
**1. Road sign B24+B26 (70 km/h) at km 65+440 (new project)**

Road signs B24+B26 (70 km/h) at km 65+440 (new project) have different retroreflectivity classes. In Appendix No. 11 to Art. 6, para. 11, item 1 and Art. 10, para. 2 of Ordinance No. RD-02-21-1-PZ, the minimum classes for the coefficient of retroreflection are defined. With regard to road signs installed on the right side of a 2nd class road from road marking materials, the requirement is that they cover at least RA2. The class of the retroreflective surface of sign B24 corresponds to class RA2, while that of sign B26 (70 km/h) complies with R3A and R3B. The different classes of the retroreflective surface lead to drivers perceiving the sign with the lower class significantly later than the one with the higher class. This results in slower perception of the sign's instructions and delayed reaction or incomplete assessment of road conditions by road users.

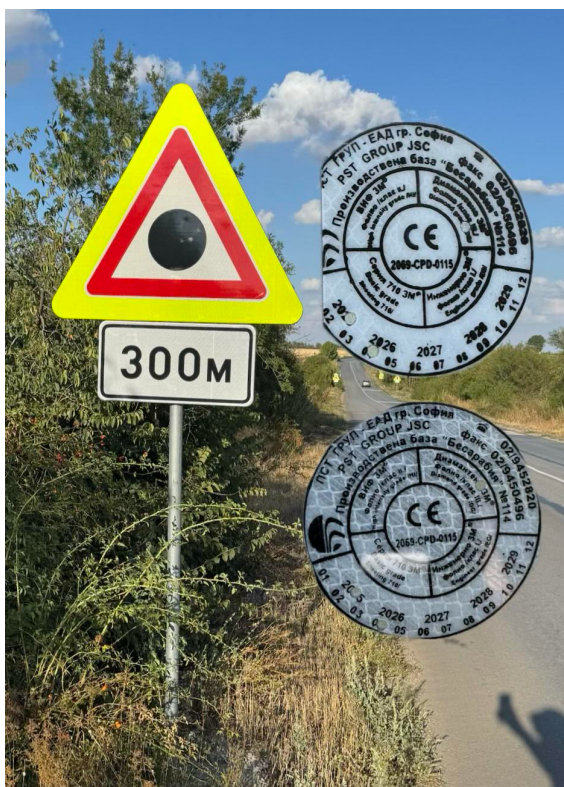
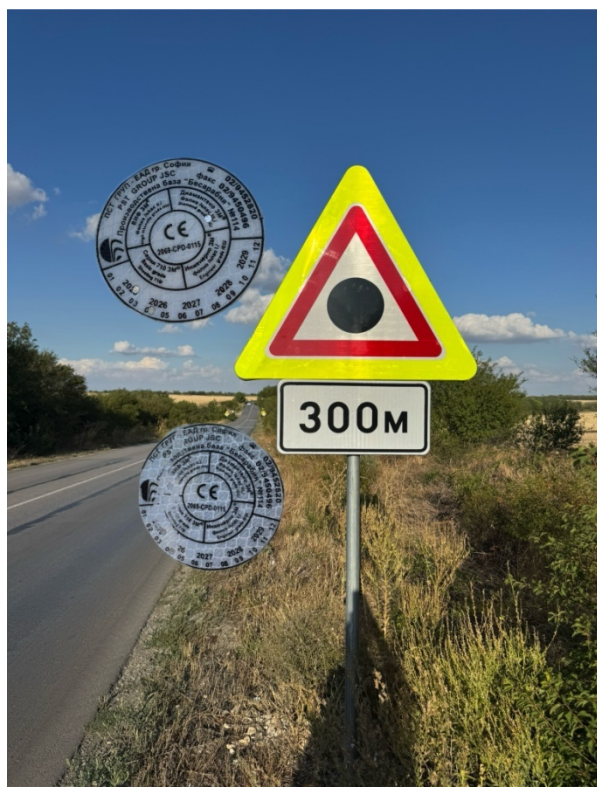
**2. Road sign – A40+T1 (300 m) at km 65+600**

Road signs A40+T1 (300 m) are located at km 65+600 according to the new PPBD project for the UKPTP. Sign A40 – “Caution! Section with concentration of road traffic accidents”, which is located 300 m before the UKPTP (right side), is damaged and deformed. The retroreflectivity class of the surface of sign A40 complies with R3A and R3B, while plate T1 (right side) meets the requirements of RA2. Here again, an imbalance is created with regard to visibility of the road signs at night and under poor weather conditions. At one and the same location, road signs with the same retroreflectivity class must be installed, in order to guarantee that road users will be able to see and recognize in time the instructions of all road signs within the road scope.

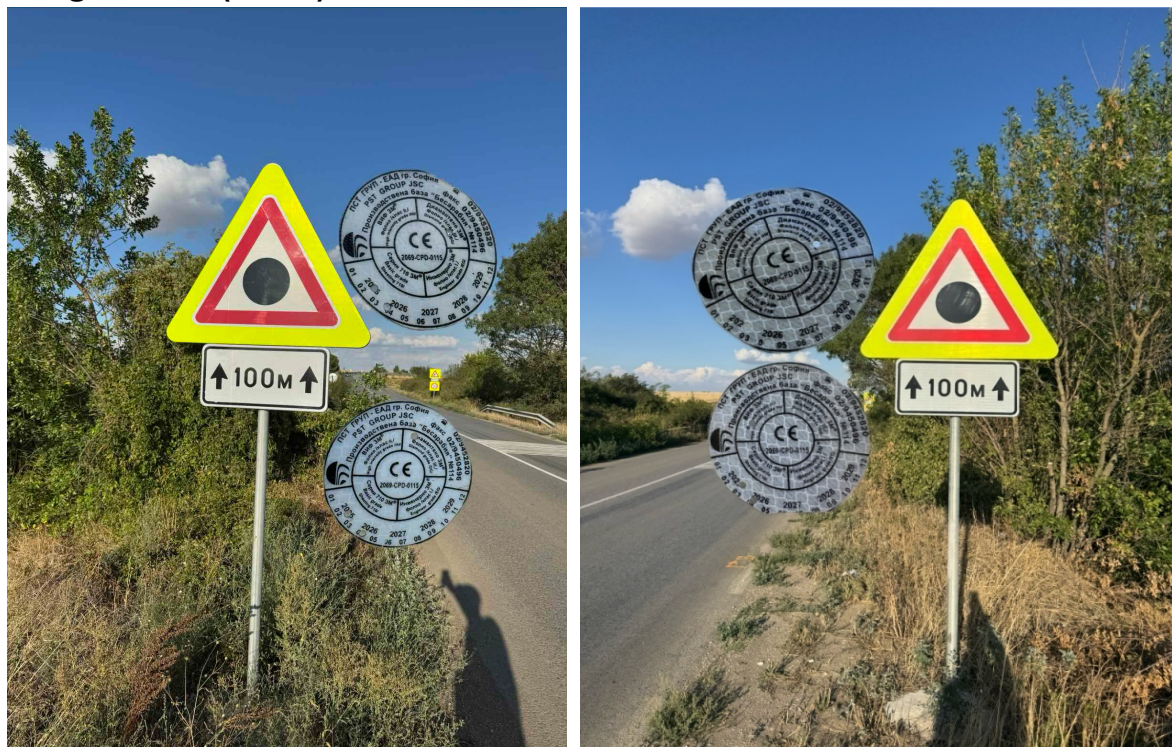
### 3. Sign A40+T2 (100 m) at km 65+750

Road signs A40+T2 (100 m) are located at km 65+750 according to the new PPBD project for the UKPTP. The retroreflectivity class of the surface of sign A40 – “Caution! Section with concentration of road traffic accidents” meets the requirements of R3A and R3B, while plate T2 (right side) meets the requirements of RA2. Here again, an imbalance is created with regard to visibility of the road signs at night and under poor weather conditions. At one and the same location, road signs with the same retroreflectivity class must be installed, in order to guarantee that road users will be able to see and recognize in time the instructions of all road signs within the road scope.

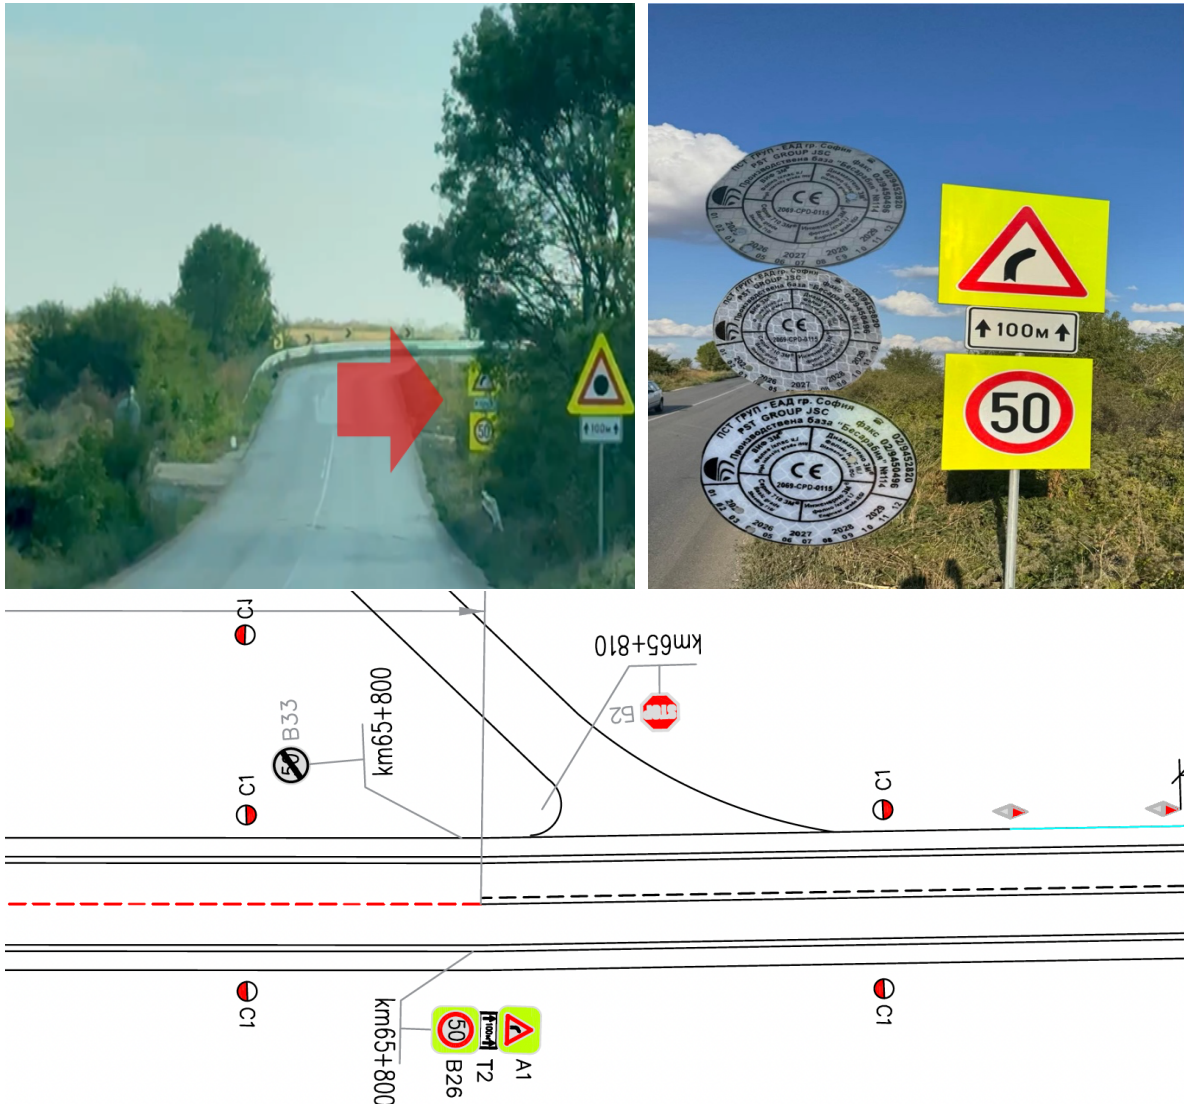
#### 4. Road signs A1+T2+B26 (50 km/h) at km 65+800

Road signs A1+T2 (100 m) + B26 (50 km/h) are located at km 65+800 according to the new PPBD project for the UKPTP. The retroreflection of the face surface of the two road signs installed on a supplementary yellow-green fluorescent background complies with class R3A and R3B. The supplementary plate T2 is not installed on a supplementary background and in this manner is visually lost. This is further intensified by the circumstance that the retroreflection characteristics of the face surface of T2 comply with RA2.

In the group of signs A1+T2 (100 m) + B26 (50 km/h), where supplementary plate T2 indicates that the length to the end of the dangerous curve is 100 m. This means that it begins after the road signs and ends at km 65+900. Upon examination of the project, it was established that the dangerous curve on the right begins at km 65+900 and ends at km 66+000. The designer likely made an error by placing T2 instead of T1 (distance to), in which manner the indication of the supplementary plate would have been valid and correct, because the dangerous curve on the right begins exactly 100 m after sign A1+T2 (100 m) + B26 (50 km/h).

The requirement of Art. 17, para. 2, item 2 of Ordinance No. RD-02-21-1-PZ is also violated, where it is stated that: “The minimum visibility distance of the road sign (in m) depending on the maximum permissible speed of travel  $V_{perm}$  (in km/h) is as follows: for  $V$  up to 50 km/h – 100 m.” In the UKPTP, the visibility conditions towards the road signs should be guaranteed and at a minimum should cover the minimum required normative visibility distances.

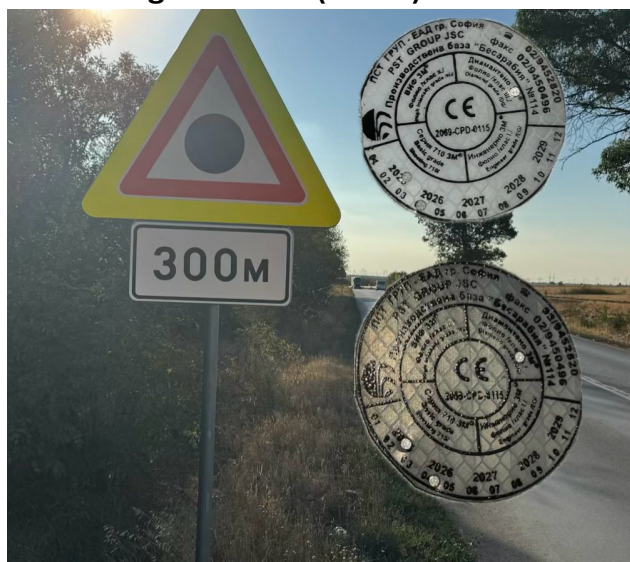
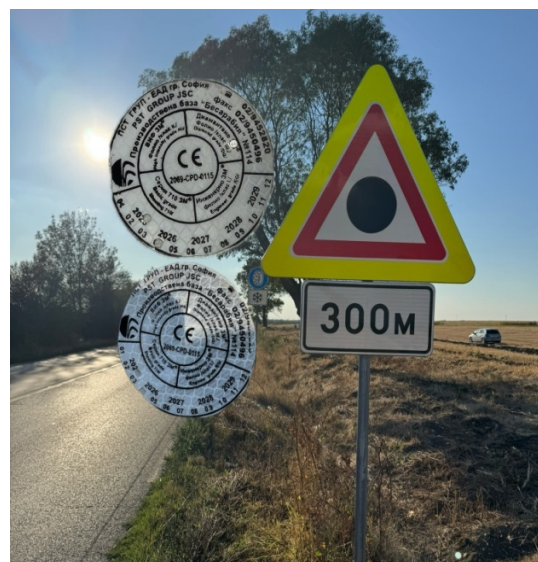
## 6. Road signs A40+T1 (300 m) at km 66+200

Road signs A40+T1 (300 m) are located at km 66+190 on the north side of the traffic lane according to the new PPBD project for the UKPTP. Sign A40 – “Caution! Section with concentration of road traffic accidents” has a retroreflectivity class of the surface corresponding to R3A and R3B, while plate T1 (right side) meets the requirements of RA2. Here again, an imbalance is created with regard to visibility of the road signs at night and under poor weather conditions. At one and the same location, road signs with the same retroreflectivity class must be installed, in order to guarantee that road users will be able to see and recognize in time the instructions of all road signs within the road scope.

Sign A40 and T1 300 m (right side) meet the visibility characteristics for retroreflectivity class R3A and R3B of the face surface. The road sign and the supplementary plate comply with the normatively defined rules described in Appendix No. 11 to Art. 6, para. 11, item 1 and Art. 10, para. 2 of Ordinance No. RD-02-21-1-PZ.

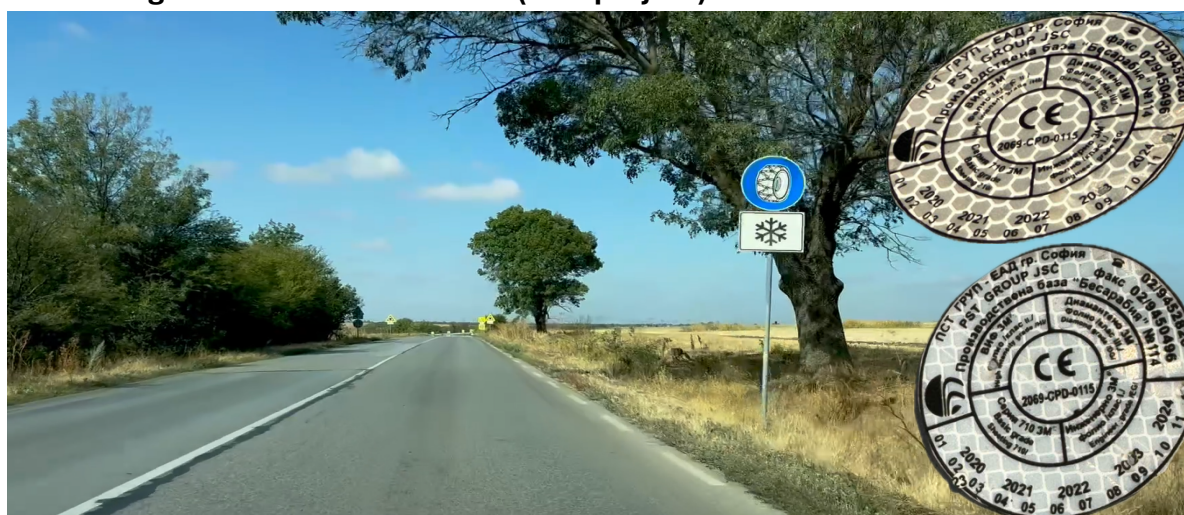
#### 7. Road sign G19+T14 at km 66+190 (new project)

Road sign G19 cannot be used in combination with supplementary plate T14, in accordance with the current requirements of Ordinance No. RD-02-21-1-PZ. Sign G19 is used in accordance with the conditions and under the procedure of Art. 103 of Ordinance No. RD-02-21-1-PZ. In Art. 190 of Ordinance No. RD-02-21-1-PZ, it is determined when, where and in combination with which other road signs supplementary plate T14 “In snow and winter conditions” may be used.

In addition, even if the provisions of the Road Signs Ordinance were to be disregarded, at least the principle should be observed that road signs which are valid only under certain weather conditions should be covered or removed when the need for their use ceases.

The road sign and the supplementary plate are installed on the right side and have a retroreflection class of the retroreflective surface of RA2.

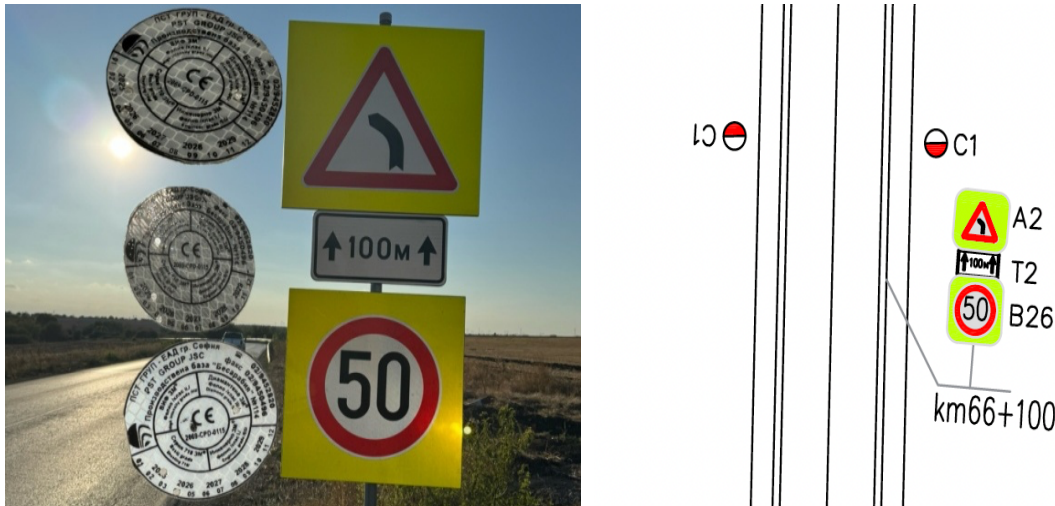
#### 8. Road sign A2+T2 (100 m)+B26 (50 km/h) at km 66+100 (new project)

Road signs A2+T2 (100 m) + B26 (50 km/h) are located at km 66+100 according to the new PPBD project for the UKPTP. The retroreflection of the face surface of the two road signs installed on a supplementary yellow-green fluorescent background complies with class R3A and R3B. The supplementary plate T2 is not installed on a supplementary background and in this manner is visually lost. This is further intensified by the circumstance that the retroreflection characteristics of the face surface of T2 comply with RA2.

The supplementary plate in this group of road signs indicates that the length of the section or the length of the dangerous curve is 100 m after the road sign, which means that this danger ends at km 66+000. In reality, however, the distance between km 66+100 and km 66+000 is a straight. The curve begins at km 66+000 and ends at km 65+900. Here the designer has again made a substantial error by placing T2 instead of T1 (100 m).
