## REPORT

Targeted Road Safety Inspection on Road II-13 in a Section with Concentration of RTAs from km 65+440 to km 66+200

12 August 2025 / from 17:30 to 18:30 GMT +3

**Final Report**

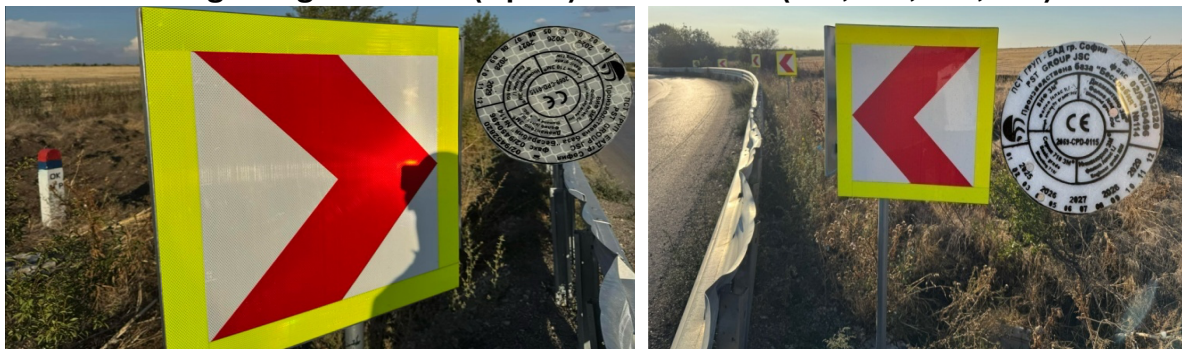
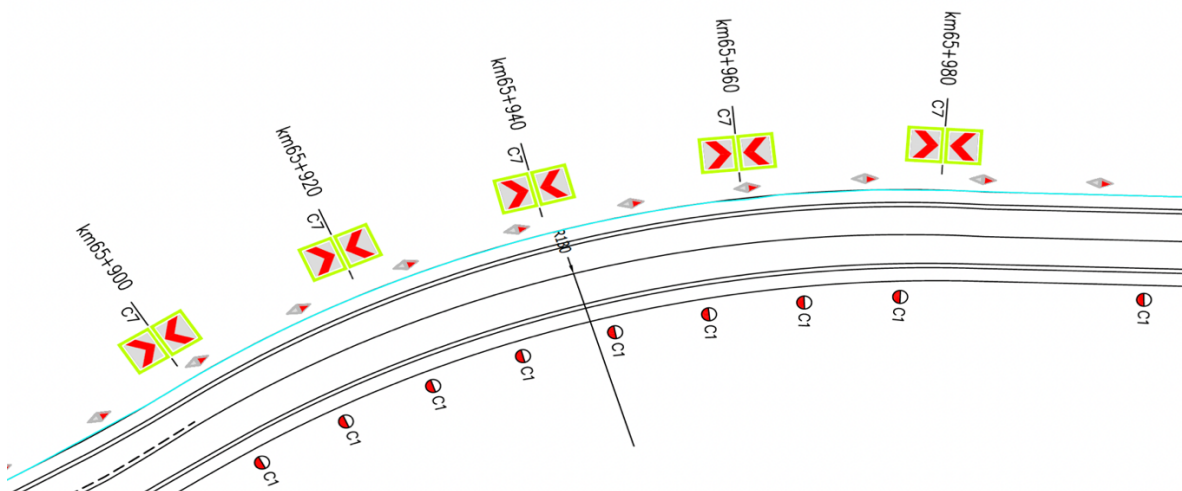
#### 9. Plates with guiding arrows C7 (5 pcs.) at km 65+980 (960, 940, 920, 900)

The retroreflective characteristics of the face side of the plates with guiding arrows C7 at km 65+980 (960, 940, 920, 900) – new project, comply with retroreflectivity class R3A and R3B.

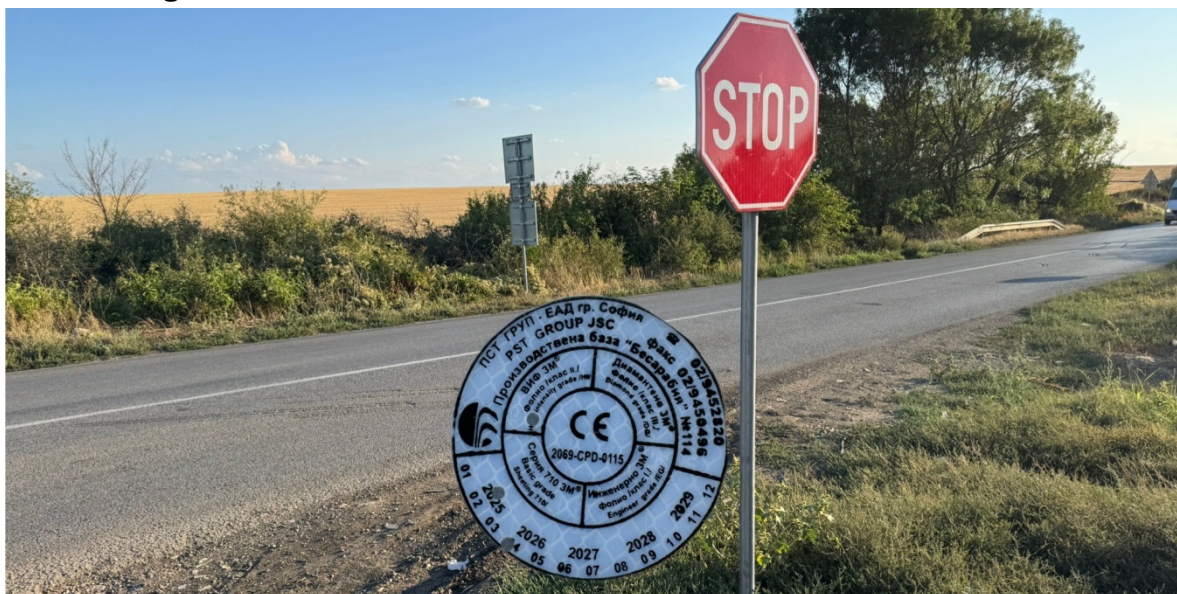
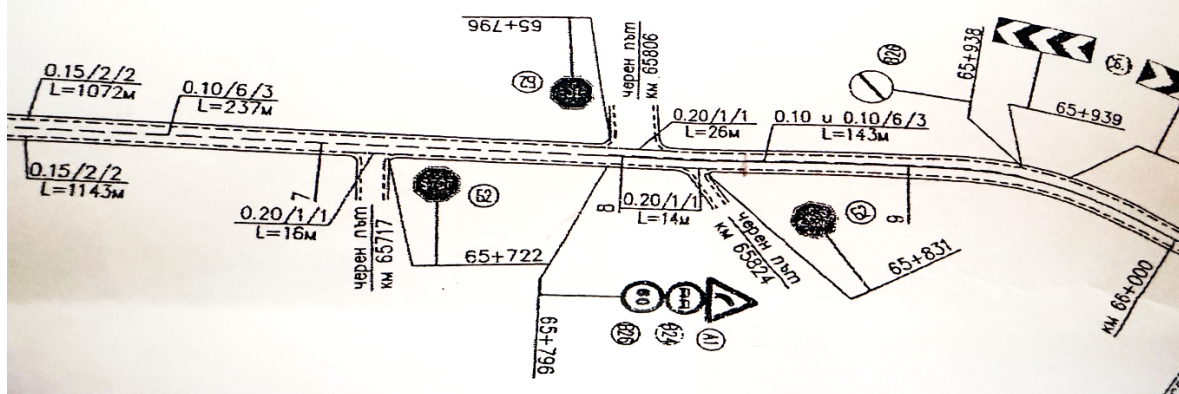
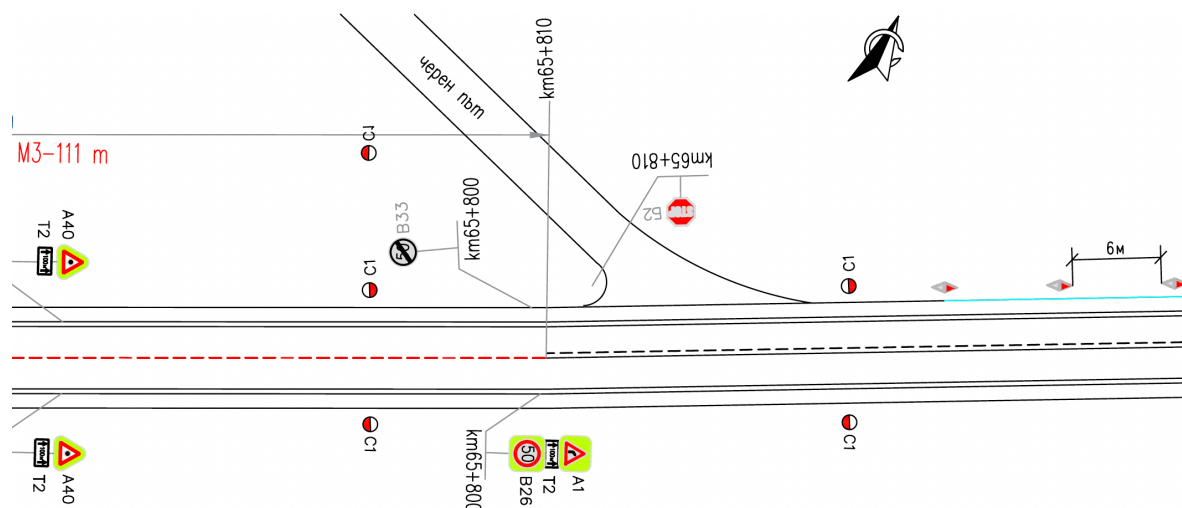
#### 10. Road sign B2 at km 65+810

Road sign B2 is located at km 65+796 according to the old project and at km 65+810 according to the new project. The difference is 14 m between the two projects. It is necessary to clarify what this discrepancy is due to.

The retroreflective characteristics of sign B2 comply with RA2, which meets the requirements of Ordinance No. RD-02-21-1-PZ.

Before the intersection on the south side in the direction of travel from town Byala Slatina to town Knezha, road sign A28 “Intersection with a road without priority from the left” is missing, while on the north side in the direction of travel from town Knezha to town Byala Slatina, road sign A27 “Intersection with a road without priority from the right” is missing. The absence of warning road signs indicating an intersection from the left or from the right in a section of road representing a combination of a horizontal and vertical curve, especially when an established UKPTP is also involved, is a deficiency of particularly great significance and a substantial omission in the traffic organization project.

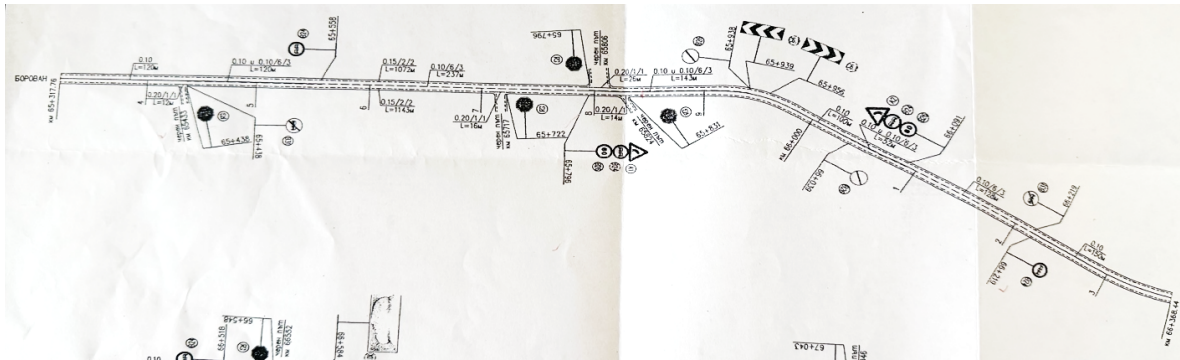
In the studied section of road II-13, there are two projects for permanent traffic organization. In the so-called “old project”, it is determined that the edge line of the road (boundary of the carriageway) shall be executed as a single broken line M3 along the entire studied section from km 66+368.44 to 65+317.76 (kilometer position according to the old project). In the new project, it is provided that the edge line of the road shall be a single continuous line M1. In the PPBD for the UKPTP, however, this change is not reflected either in the explanatory note or in the drawing attached to it. On-site inspection established that the road marking at the edge line, where it exists at all, corresponds to a single broken marking M3.

Figure 45 – PPBD – old project between km 65+317.76 and km 66+368.44.

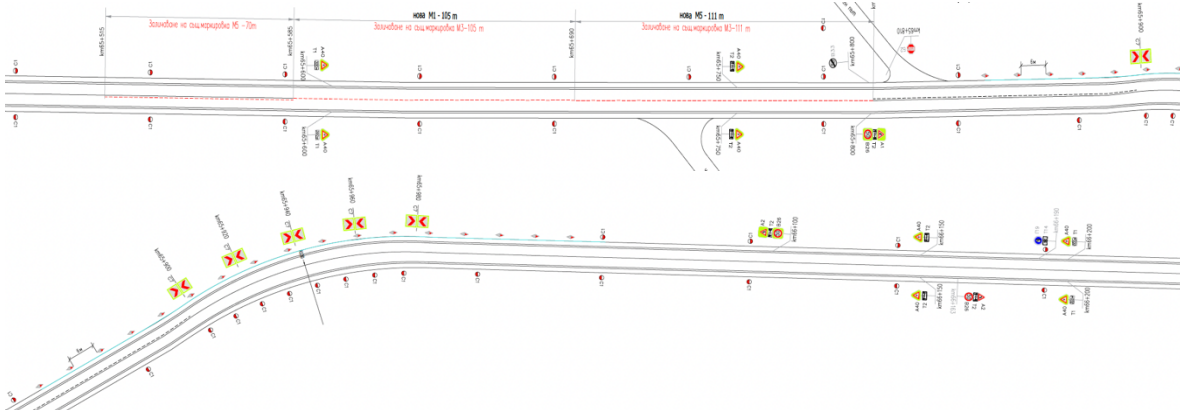
Figure 46 – PPBD for the UKTP – new project between km 65+515 and km 66+200.

Marking M3, which should outline the boundary of the carriageway, is missing along the entire length of the section, on both the left and the right side. This is a serious omission from the standpoint of road safety, as at dusk, in rain or when dazzled by oncoming lights, drivers lose visual orientation regarding the road clearance gauge and the location of the edge of the carriageway.

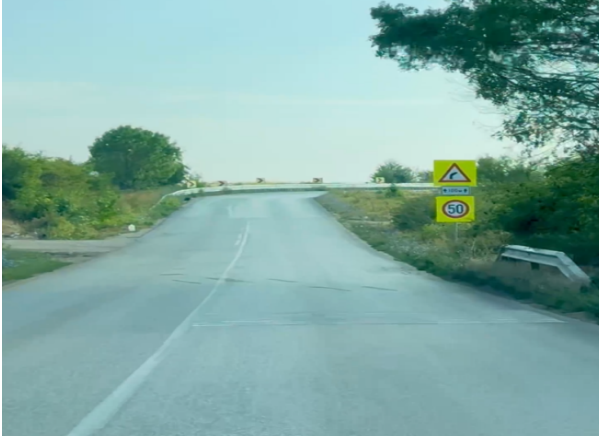
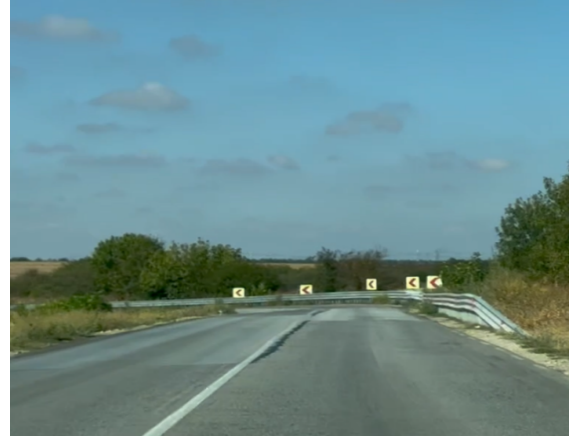
*Figure 49 – Overall condition of the road marking as of September 2025, after the safety measures for the UKPTP were implemented.*

*Figure 50 – Overall condition of the road marking as of September 2025, after the safety measures for the UKPTP were implemented.*

During the on-site inspection, it was established that the center line M1, M3 and M5 was laid in August 2025, but its execution does not comply with the normative requirements for busy 2nd class roads with traffic intensity exceeding 4,000 vehicles/day. Acrylic paint was used, which is not permissible for such a class of road, due to insufficient wear resistance and reduced durability under high traffic intensity.

The center marking has unevenly laid glass beads – in places, lack of beads and uneven coverage is already observed. During the inspection, it was established that the beads have not sunk into the paint layer, as the layer itself is executed too thinly. This leads to reduced retroreflectivity and impaired night visibility. The color of the applied paint is visibly soiled and does not meet the requirements, which further reduces the effectiveness of the marking at dusk and in wet conditions, as well as during the day.

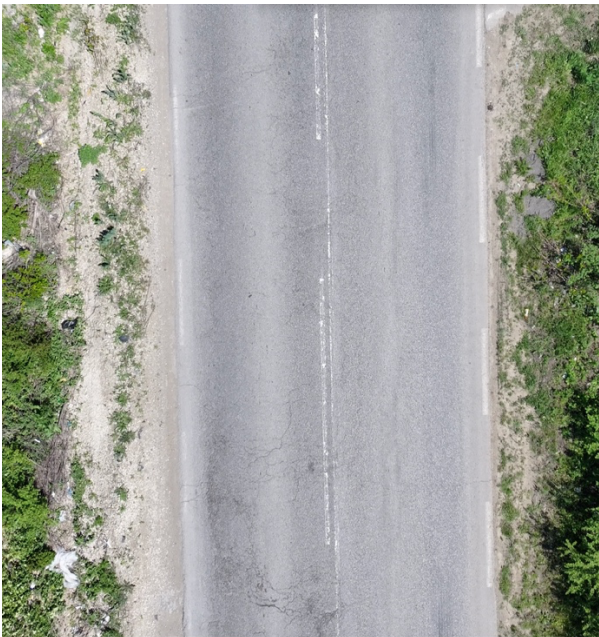
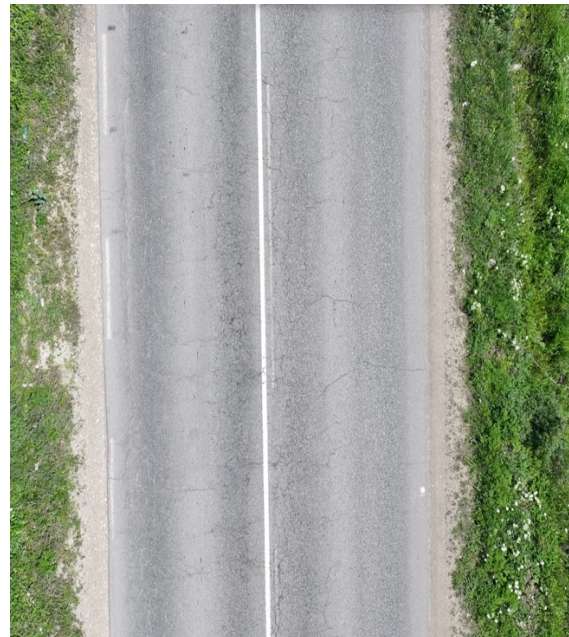
*Figure 51 – Condition of the road marking as of May 2025 before the safety measures for the UKPTP were implemented – footage captured by the remote sensing method.*

*Figure 52 – Condition of the road marking as of May 2025 before the safety measures for the UKPTP were implemented – footage captured by the remote sensing method.*

During the remote sensing survey, it was established that the center line is partially preserved, but strongly faded, with numerous interruptions along its length and lack of clear delineation. The marking layer has reduced retroreflection, and in places a visible

marking strip is completely missing. This indicates significant wear of the surface film and loss of microspheres (glass beads) that ensure night visibility. The same is confirmed by the close-up photos taken on 26 May 2025.

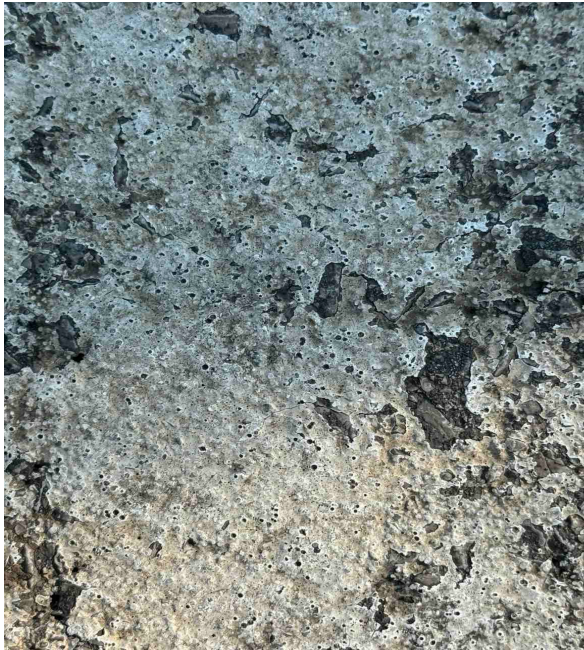
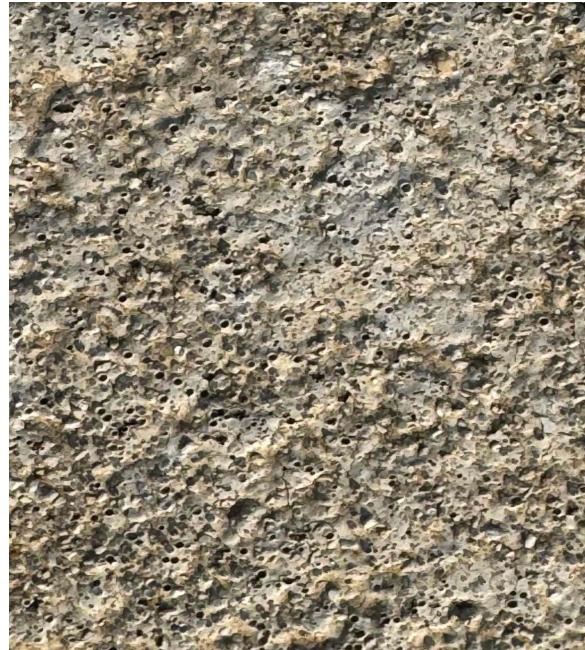
*Figure 53 – Condition of the road marking as of 26 May 2025.*

*Figure 54 – Condition of the road marking as of 26 May 2025.*

In the detailed close-up photos, a completely lost surface structure of the applied paint is observed – glass bead particles are almost entirely absent, and the binding polymer layer is porous and with compromised integrity. This is a characteristic sign of marking aging over 12–18 months without maintenance, or of poor-quality initial laying, in which sufficient quantity of beads and binding agent was not ensured.

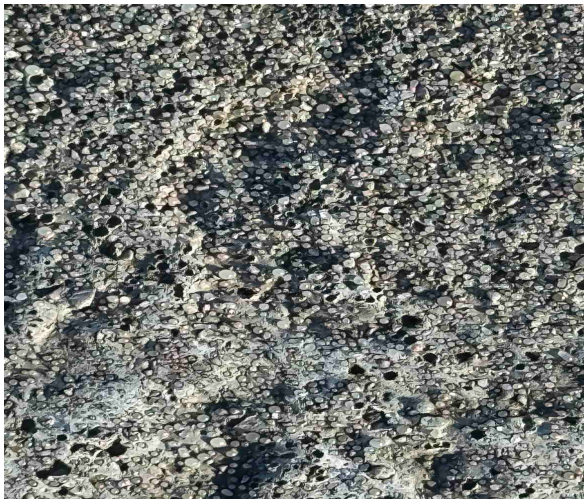
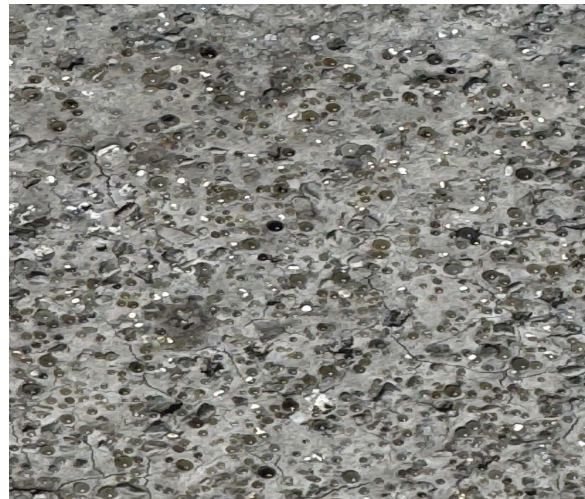
*Figure 55 – Condition of the road marking as of 10 August 2025.*

*Figure 56 – Condition of the road marking as of 10 August 2025.*

After the laying of the new road marking layer, substantial defects continue to be observed, related to the quality of execution and the laying technology. In numerous sections, loss of glass beads is established, which is a direct indicator of improper application or non-compliance with technological requirements.

In visual inspection, it is seen that the beads have not sunk sufficiently into the paint layer, which means that the technological regime of temperature and material quantity was not observed during application. It is recommended that approximately 60–65% of the bead diameter be embedded in the paint, in order to ensure good adhesion and stability. With less embedding, the beads remain partially exposed on the surface and are easily chipped off under tire pressure, especially during movement of heavy goods vehicles.

The probable cause of this is an improper ratio between the quantity of paint and glass beads, in which the paint layer is excessively thin and its thickness does not allow sufficient embedding of the beads. As a result, surface delamination and destruction of the upper film are observed, which further accelerates the process of bead loss and reduction of retroreflection.

These defects are an indicator of non-compliance with the requirements of BDS EN 1423 (Road marking materials. Drop-on materials. Glass beads, antiskid aggregates and mixtures of the two products) and BDS EN 1436 (“Road marking materials. Road marking performance for road users and test methods” – this standard covers requirements for daytime and night visibility, color and durability). The violation of technology leads to sharp deterioration of night visibility and the reflective capability of the marking, while the actual service life of the applied layer will likely be significantly shorter than the normative (under 6 months).

The road marking is in deteriorated operational condition, with a low coefficient of reflective capability and weak visibility under night and wet conditions. It does not comply with the applicable standards and must be entirely replaced by laying a new layer of thermoplastic or cold-plastic marking with embedded glass beads. Retroreflectometric measurements (RL and Qd) are recommended for confirmation of the values, but based on visual signs, the marking is below the critical threshold for safety.

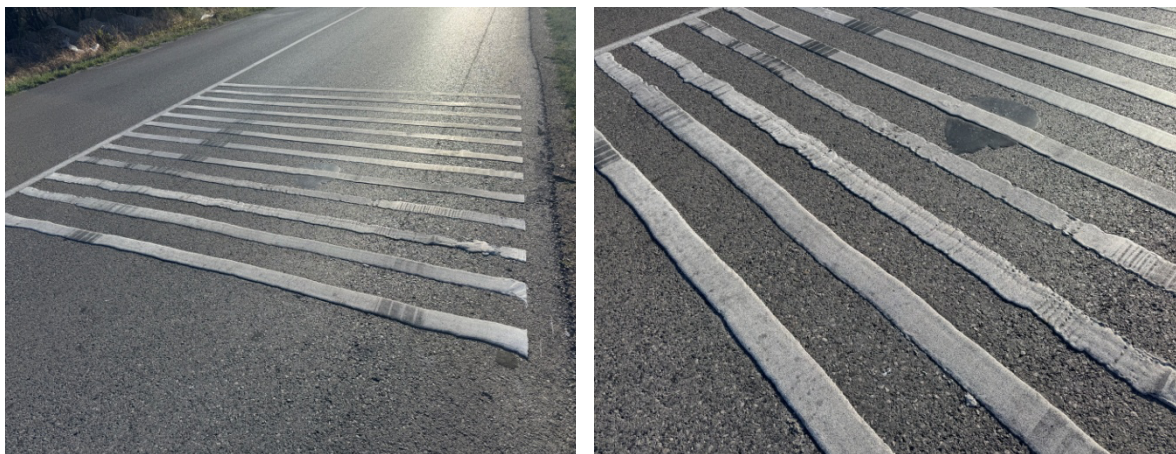
Before the beginning of the section with concentration of road traffic accidents, in both directions, warning rumble strips of type M20 are laid – four zones with twelve transverse strips each. During the inspection, it was established that these rumble strips also do not comply with normative requirements. It is visible that the laying technology was not observed during execution – the material has “spilled”, uneven edges and local thickenings have formed. The thickness of the applied material varies between 6 and 12 mm, which is outside the permissible limits of  $10 \text{ mm} \pm 10\%$  according to Ordinance No. 2. This marking is not part of either the old project or the project for permanent traffic organization and safety for the UKPTP.

*Figure 57 – Transverse rumble marking – M20.*

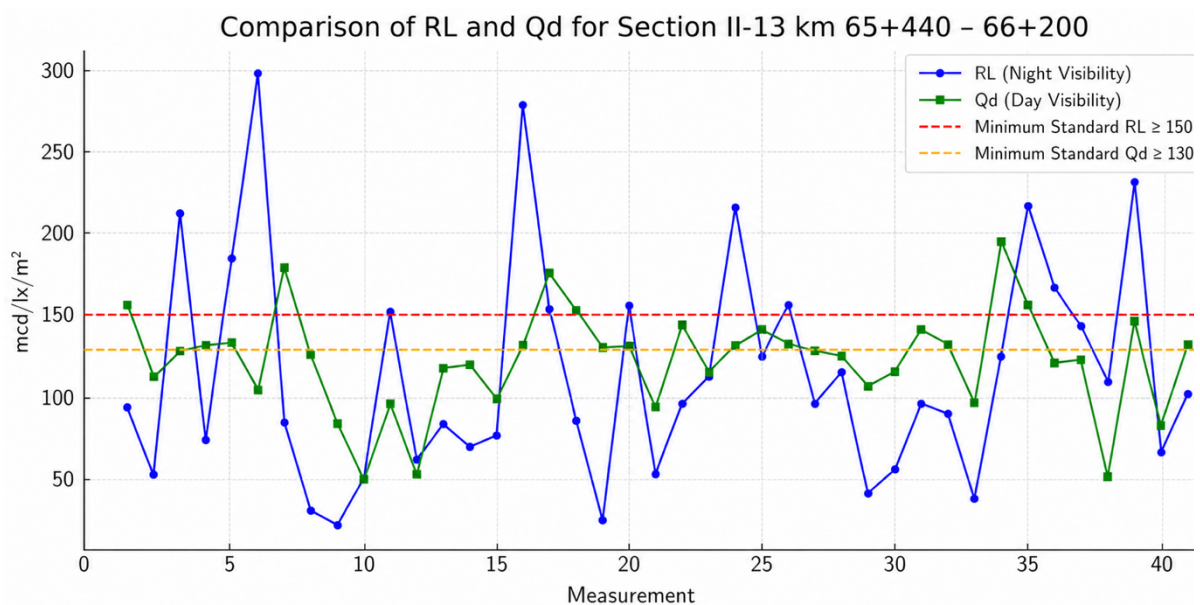
The fluctuations between individual measurements are exceptionally large – from 26 to 298  $\text{mcd/lx/m}^2$ , which is a sure sign of uneven embedding of glass beads and varying thickness of the applied paint layer. This is usually a result of deviations in the laying technology or poor-quality execution. The established values correspond to class R2Q2, which is below the minimum requirements for roads of the republican road network.

The overall condition of the road marking in this section can be defined as unsatisfactory. It does not ensure the necessary visibility at night and under reduced illumination, being in places practically invisible. Non-uniformity along the length of the alignment is established, which leads to visual interruption and disorientation of drivers. The marking does not meet the minimum operational requirements for class R3Q3 and must be deemed unfit for operation.

Figure 59 – Statistics from measurement with retroreflectometer..

The probable causes for this condition are related to insufficient paint layer thickness, improper distribution and embedding of glass beads (below 60%), as well as natural wear

Based on the findings made, complete restoration of the road marking with materials complying at least with class R3Q3, and where possible with class R4Q4, is recommended. Upon re-laying, uniform embedding of glass beads between 60 and 65% must be ensured, as well as a minimum layer thickness of not less than 0.6 mm for paint or 1.5 mm for cold plastic. Control measurement 7–10 days after laying is recommended, as well as subsequent monitoring during the first six months of operation. Additionally, periodic cleaning of the road marking is expedient, in order to prevent accumulation of dust and contaminants that reduce its reflective properties.

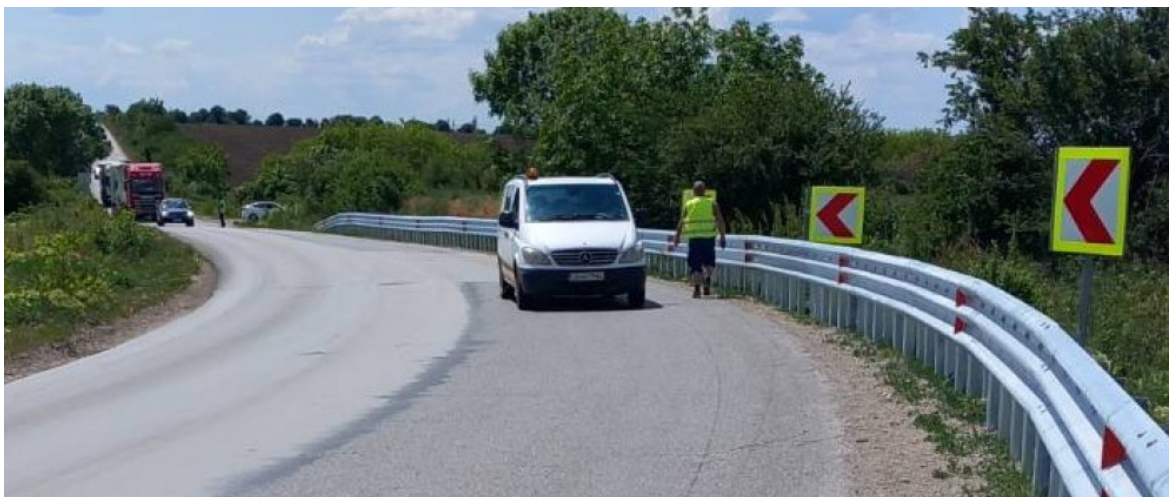
The road restraint system between km 65+840 and km 66+010 (new project) was installed as one of the safety measures for the section with concentration of road traffic accidents. During the on-site inspection, it was established that the restraint system has rather the opposite effect, and after its installation it has contributed to the occurrence of more severe injuries, as vehicles traveling in the direction of town Byala Slatina have no possibility to undertake an evasive maneuver and avoid impact. The road accidents end with the vehicle traveling in this direction being crushed against the restraint system.

Figure 63 – Photo from the installation of the road restraint system on 20.05.2025. Source: <https://api.bg/bg/novini/montirani-sa-novi-mantinel-na-put-ii-13-byala-slatina-knezha-pri-66-i-km-za-obezopasyavane-na-uchastuka-s-kontsentratsiya-na-intsidenti.html>

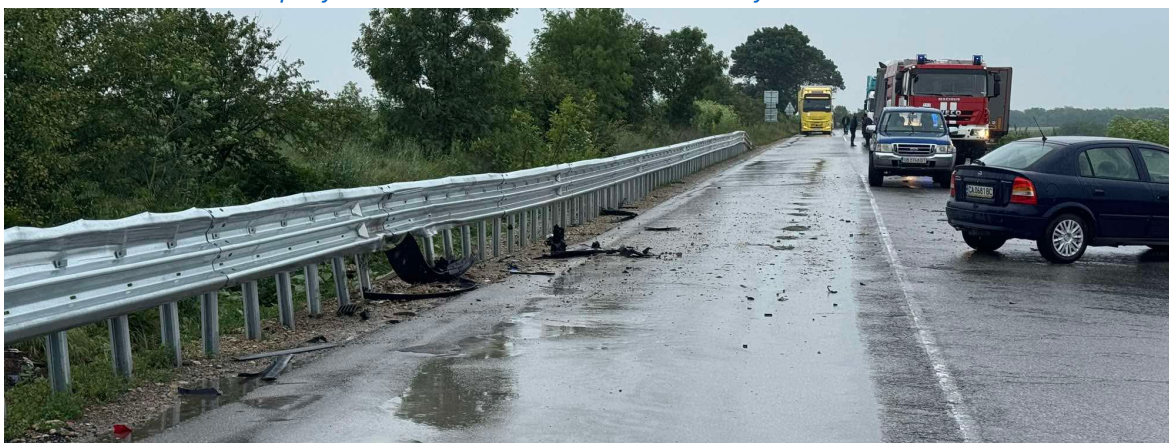
Figure 64 – Photo reflecting the current condition of the road restraint system on 25.05.2025 in the zone of the section with concentration of road traffic accidents.

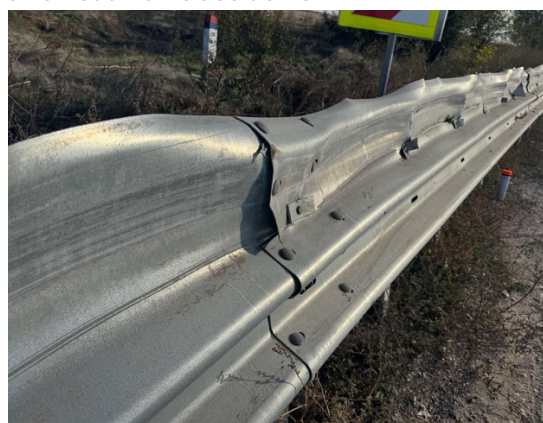
Figure 66 – Condition of the road restraint system after the safety measures for the UKPTP were implemented. From the traces of numerous impacts, it is clearly evident that the cause of the road accidents is complex and the restraint system is not the best solution.

For this reason, it is recommended to consider how appropriate it is to have a road restraint system in the section with concentration of accidents. A similar measure would reduce the risk for skidding vehicles and limit the possibility of serious head-on collisions, while at the same time allowing drivers greater space to avoid collision.

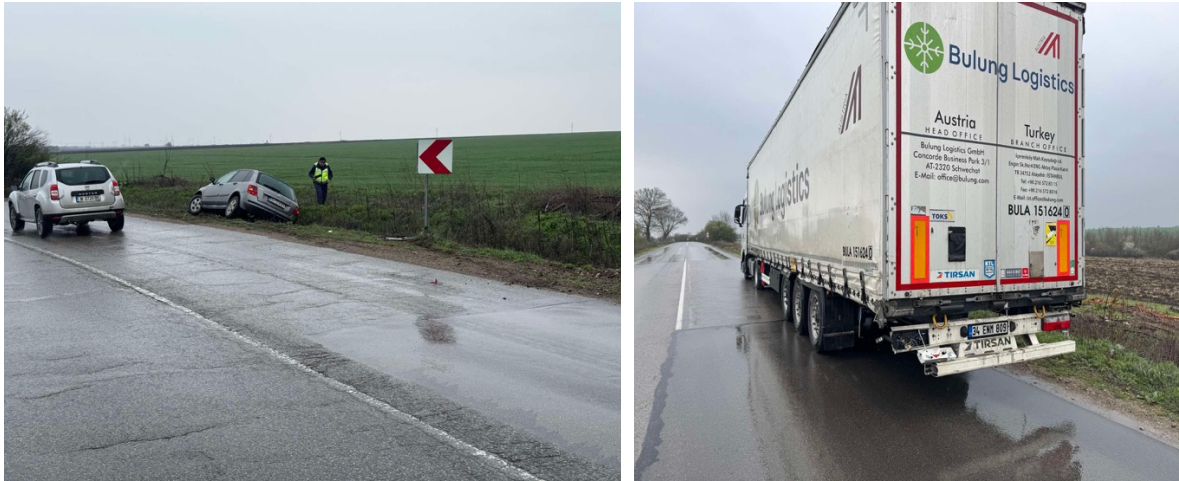
Figure 67 – In the two images above, an absolutely analogous road accident is visible, which occurred before the installation of the restraint system (28.03.2025). The heavy goods vehicle was traveling in the direction from town Byala Slatina to town Knezha, while the passenger car was traveling in the opposite direction. In this case, due to the absence of the road restraint system, the driver of the passenger car undertook an evasive maneuver and left the carriageway. As a result of the road accident that occurred, there were no injuries, only material damages.

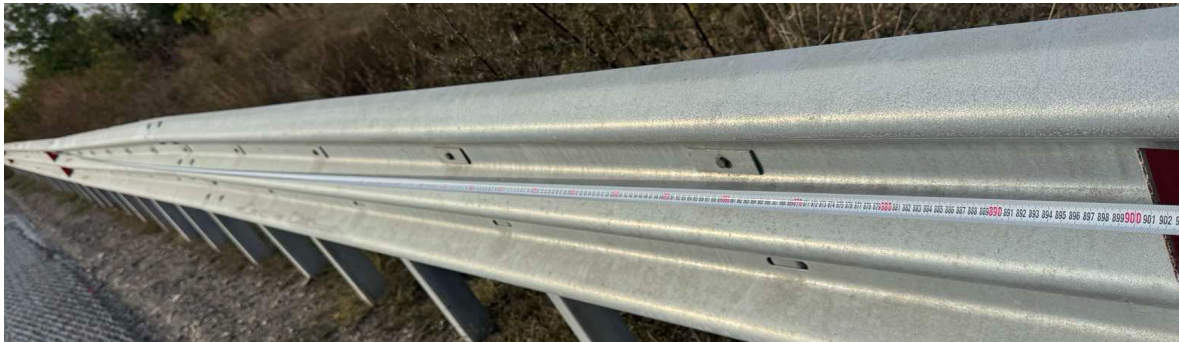
In the project for permanent traffic organization, it is provided that C14.1 be installed at intervals of 6 m. During the inspection, it was established that they are installed at intervals of 9 m.

Figure 68 – Measuring the distance between C14.1.

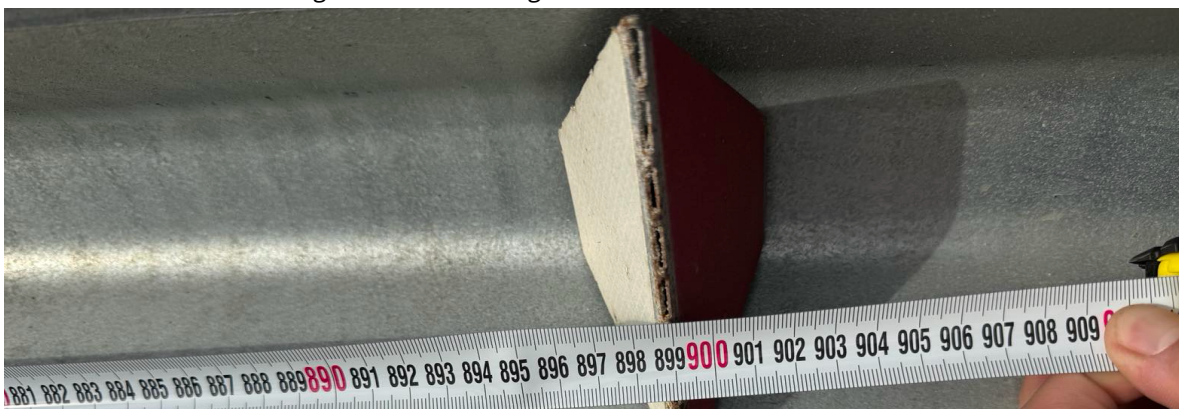
Figure 69 – Indicate the spacing between C14.1.

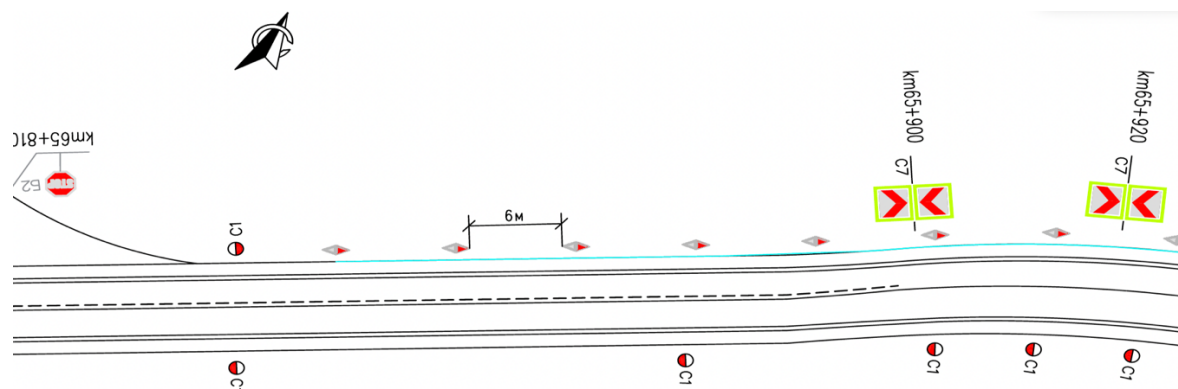
Figure 70 – Project instructions for the installation of C14.1 elements on the road restraint system according to the PPBD for the UKPTP, and measurement of how they are actually installed.

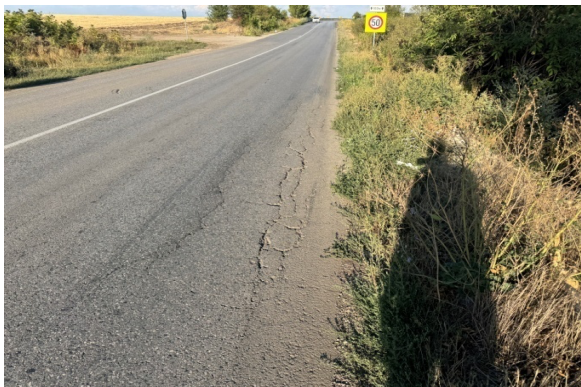
The pavement is in an advanced stage of functional degradation with local structural defects. Pronounced longitudinal cracks are observed (along the axis and in the edge zone – the boundary of the traffic lane), sections with ruts and lateral shoving, torn strips along the edge with settlement towards the shoulder, as well as numerous patches of different age and quality. The surface layer is polished in places (especially in the curves and in the wheel tracks – the ruts), and in individual zones there is bituminous “film”/fatting, which substantially reduces microtexture and skid resistance. In some zones, differential settlement is observed, which forms transverse “steps” and longitudinal waves.

The main causes are a combination of aging of the binder material, water infiltration through cracks and poor drainage, insufficient bearing capacity of the shoulder (leading to edge deformations), and heavy goods/agricultural traffic, which accelerates rutting and crushing of thin layers. In the curves, uneven superelevation/cross slope is probably also added, which retains water towards the inner edge and further reduces skid resistance. The shadow from vegetation retains moisture, delays drying and promotes polishing of the wearing course.

*Figure 72 – Clearly visible longitudinal crack.*

Urgent measures (maintenance): machine cleaning and hot filling of cracks with polymer-modified bitumen; local “wedging” of the edge and restoration of the shoulder;

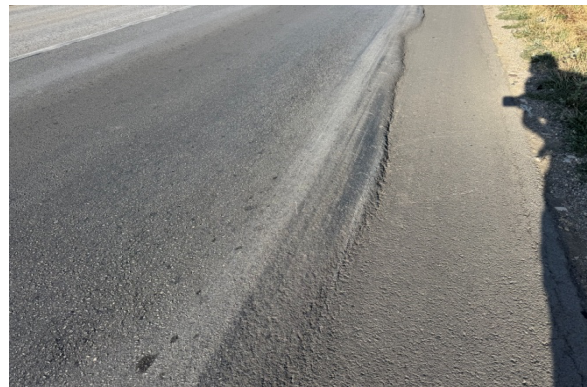
*Figure 73 – Poor-quality asphalt at one of the patches.*

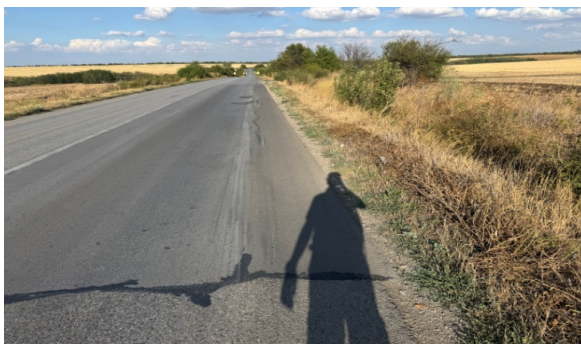
*Figure 74 – General view before one of the patches, at which lateral shoving is observed.*

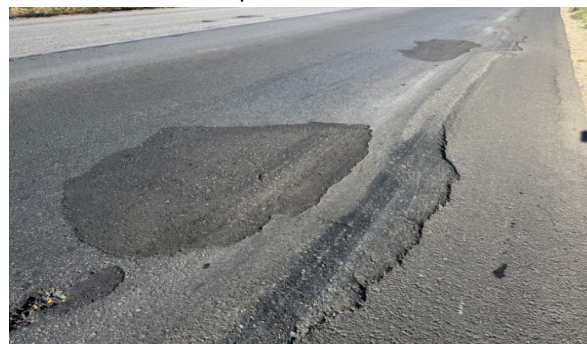
*Figure 75 – Zone with clearly visible lateral shoving and a formed step with a height exceeding 7 cm.*

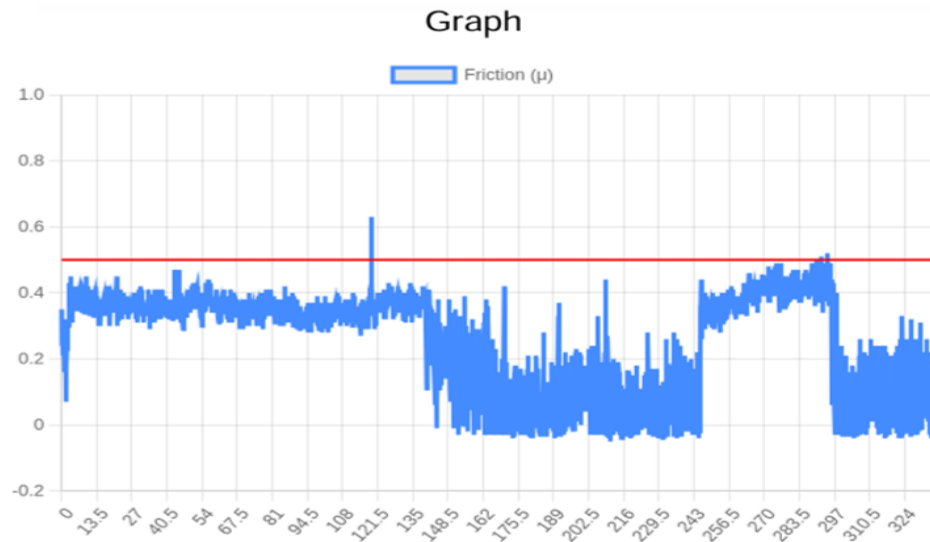
Figure 80 – Results from measurement performed with device SARSYS T2GO.

The measurement was performed on 06.08.2025 in a section with a length of approximately 330 m, at an average device speed of about 6 km/h and under wet test conditions.

- Average friction coefficient ( $\mu$ ): 0.24, with a required threshold  $\mu \geq 0.55$  – categorically FAIL, “PASS” percentage only 0.33%.
- Maximum value: 0.63, minimum:  $-0.05$ , which shows local sections with practically zero or negative friction.
- Temperature conditions during the test: air  $\sim 35.8$  °C, pavement  $\sim 37.5$  °C, humidity  $\sim 47$  %.

These results show that the braking distance on wet pavement is extended by more than twice compared to the reference value at  $\mu = 0.55$ . During sharp maneuvers and in curves, the risk of side skidding, leaving the carriageway and impact into roadside structures increases significantly, especially during rain and night conditions. The low and uneven friction is an indicator of loss of macrotexture of the asphalt pavement and of the presence of zones with different aggregate fraction in the surface layer, which leads to formation of a water film.

Based on the results and in accordance with Ordinance No. RD-02-21-1/23.11.2023, the introduction of road sign A15 “Danger of skidding” along the entire length of the studied section is recommended until the problem is definitively resolved.

The necessary long-term measures include milling of the wearing course or thin-layer high-friction surface treatment (HFST) in order to restore macrotexture, homogenize the upper layer and ensure stable friction across the entire width of the carriageway. After performing these activities, repeated measurements must be made to confirm achievement of the required  $\mu \geq 0.55$  without local “holes” along the length.

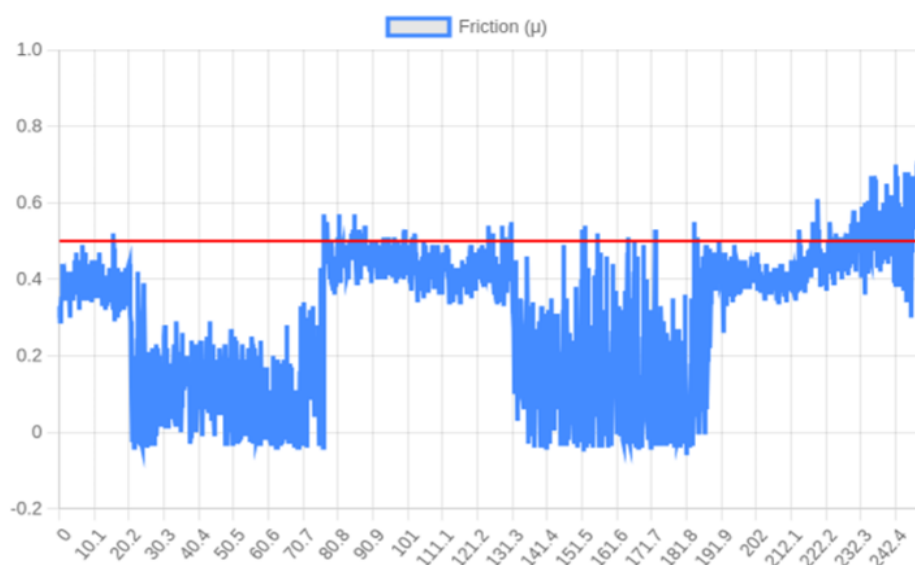
Figure 81 – Graph of the results per kilometer.

The graph from the measurement clearly outlines extensive sections with  $\mu$  values in the range of 0.20–0.30, as well as deep local drops to around 0.0, at which friction is

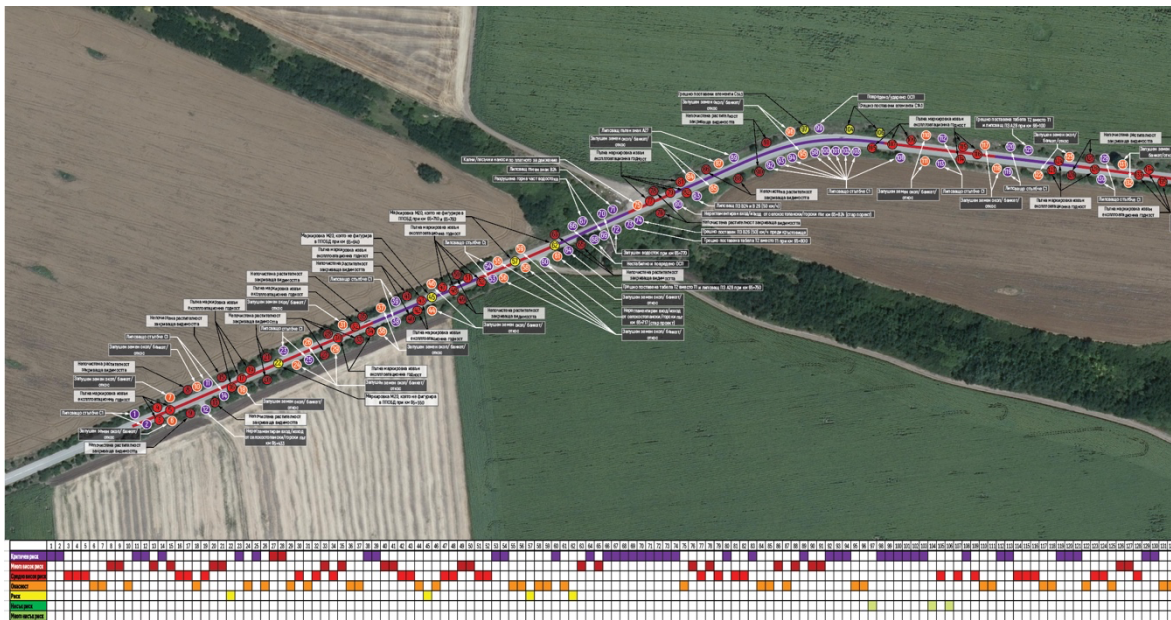
*Figure 85 – Risk analysis using the remote sensing method. Full version of the map in Appendix A to this document.*

The risk assessment conducted for the section of road II-13 (km 65+440 – km 66+200) shows a predominantly high to very high risk, with a significant concentration of critical sections in the first 400–500 meters. The identified problems are systemic and stem both from insufficient maintenance and wear of the road pavement and marking, as well as from lack of uniformity in the restraint systems, drainage and visibility of road signs.

Urgent corrective measures are necessary, including replacement of road marking, restoration of restraint systems and ensuring full visibility in the section.
